Access Compliance Report

Public Rights-of-Way

(Curb Ramps)

Intersection ID: 3991	Main Street: BRIDGEPATH_TL	Cross Street: DOWNING_CREEK_DR	Location: SE
ADA ID: A8ABE9095DD7	Ramp Type: BlendTrans1	Initial Pass/Fail: Fail	Overall Compliance: No
Severity Score: 10			
Codes/Mitigation Info/Possible Solution		Field Measurements/Component Compliance

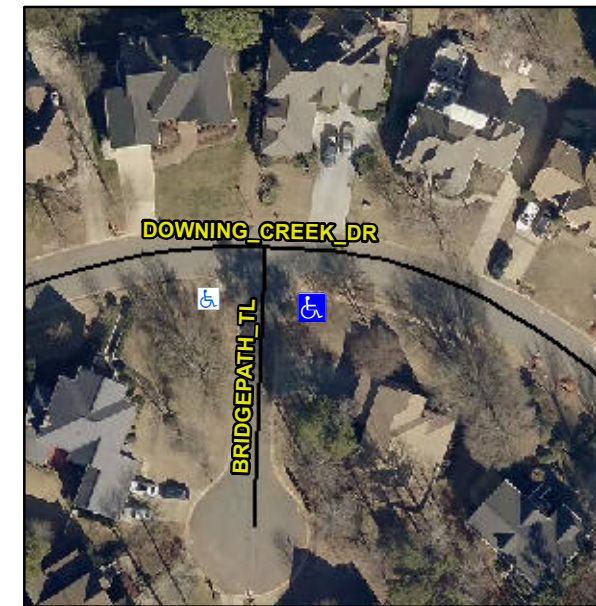
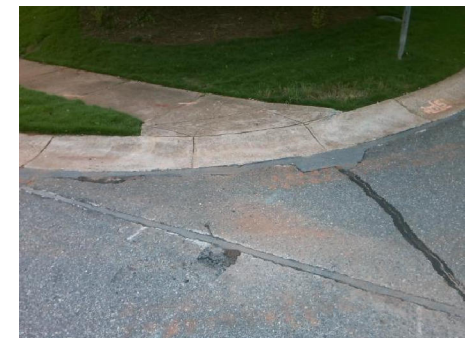
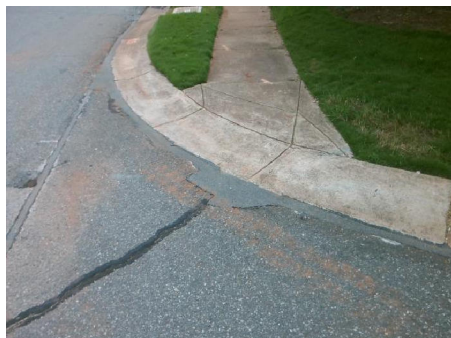
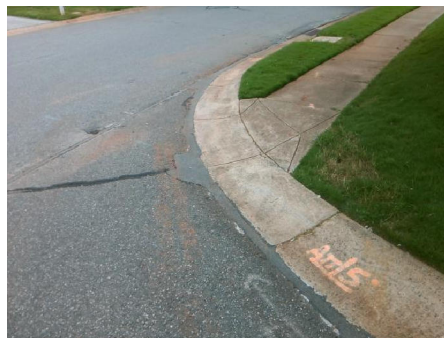
Not Found, R304.5.1, R304.5.3

Compliance	Description	Data	Compliance	Description	Data
N/A	Ramp Length (in)	14.5	Yes	BlendTrans Slope (%)	1.3
No	Ramp Width (in)	47.5	No	BlendTrans XSlope (%)	4.6
N/A	Flare Type LT	N/A	N/A	Flare Type RT	N/A
N/A	Flare Slope LT (%)	N/A	N/A	Flare Slope RT (%)	N/A
N/A	Flare Traversable LT?	N/A	N/A	Flare Traversable RT?	N/A
N/A	Landing Length (in)	N/A	N/A	DWS Provided?	N/A
N/A	Landing Width (in)	N/A	N/A	DWS Contrast?	N/A
N/A	Landing Slope (%)	N/A	N/A	DWS Length (in)	N/A
N/A	Landing X Slope (%)	N/A	N/A	DWS Full Width?	N/A
N/A	Landing Curb? (Y/N)	N/A	N/A	DWS Offset (in)	N/A
N/A	Shared Landing?	N/A			
N/A	Gutter Ponding?	N/A	N/A	Gutter Slope (%)	N/A
N/A	Gutter Lip Ht (in)	N/A	N/A	Gutter X Slope (%)	N/A
N/A	Painted X Walk1?	No	N/A	Painted X Walk2?	N/A
	X Walk 1 Direction	To W		X Walk 2 Direction	N/A
	X Walk 1 Width (in)	N/A		X Walk 2 Width (in)	N/A
	X Walk 1 Slope (%)	4.5		X Walk 2 Slope (%)	N/A
	X Walk 1 X Slope (%)	4.6		X Walk 2 X Slope (%)	N/A

N/A	Ramp inside XWalk1?	N/A	N/A	Ramp inside XWalk2?	N/A
	Road Slope (%)	4.6		Clear Space?	N/A
	Road X Slope (%)	4.5	N/A	Clear Space to XWalk (in)	N/A
N/A	Any Obstructions?	N/A	N/A	Storm Grate/Utility Hazard?	N/A
	Obstruction Type			Storm Grate/Utility Type	
		N/A			N/A
			Yes	Surface Condition? (G/P)	Good
			No	Curb Slope (%)	18.1

Remove & Replace Curb Ramp With Two New Directional Ramps or Equivalent.
