Access Compliance Report Public Rights-of-Way (Curb Ramps)

Intersection ID: 18920 Main Street: TYVOLA RD **Cross Street: WESTPARK DR** Location: NE **Overall Compliance: No Severity Score: ADA ID: A8AC74903AC4** Ramp Type: PerpDiag Initial Pass/Fail: Fail 8.75

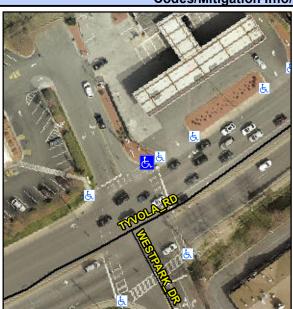
42.0 Yes Ramp XSlope (%) No Ramp Width (in) 0.9 N/A N/A Flare Type LT N/A Flare Type RT N/A N/A N/A N/A Flare Slope RT (%) N/A Flare Slope LT (%) N/A Flare Traversable LT? N/A N/A Flare Traversable RT? N/A N/A N/A N/A **DWS Provided?** N/A Landing Length (in) N/A Landing Width (in) N/A N/A **DWS Contrast?** N/A N/A N/A N/A Landing Slope (%) DWS Length (in) N/A N/A Landing X Slope (%) N/A N/A DWS Full Width? N/A N/A Landing Curb? (Y/N) N/A N/A DWS Offset (in) N/A N/A N/A Shared Landing? N/A **Gutter Ponding?** N/A N/A Gutter Slope (%) N/A N/A Gutter Lip Ht (in) N/A N/A Gutter X Slope (%) N/A N/A Painted X Walk1? Yes N/A Painted X Walk2? Yes X Walk 1 Direction To SW X Walk 2 Direction To SE N/A 72.0 N/A 72.0 X Walk 1 Width (in) X Walk 2 Width (in) X Walk 1 Slope (%) 1.6 X Walk 2 Slope (%) 1.3 X Walk 1 X Slope (%) 1.8 X Walk 2 X Slope (%) 2.3 N/A N/A Ramp inside XWalk2? Ramp inside XWalk1? Yes Yes Road Slope (%) 2.0 N/A Clear Space? N/A N/A Road X Slope (%) 0.9 Clear Space to XWalk (in) N/A N/A N/A N/A Any Obstructions? Storm Grate/Utility Hazard? N/A **Obstruction Type** Storm Grate/Utility Type N/A N/A Yes Surface Condition? (G/P) Good

WESTPARK DR Street 1 Name Signal Stop Condition-Street 2 **TYVOLA RD** Street 2 Name Stop Condition-Street 1 Signal Possible Solutions: Remove & Replace Curb Ramp With Two New Directional Ramps or Equivalent. Surveyor Notes: N/A PROW/ADA: Not Found, R304.5.1
