Access Compliance Report

Public Rights-of-Way

(Curb Ramps)

Intersection ID: 48957	Main Street: POLLYS_GARDEN_CR	Cross Street: FRANKLIN_SQUARE_RD	Location: NE
ADA ID: A8BE09EE776B	Ramp Type: Perp	Initial Pass/Fail: Fail	Overall Compliance: No
		Severity Score: 1.25

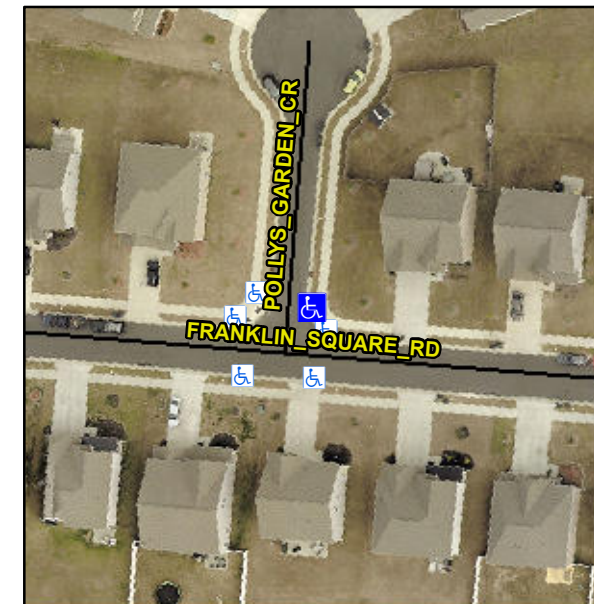
Not Found, R304.5.3

Compliance	Description	Data	Compliance	Description	Data
N/A	Ramp Length (in)	47.5	Yes	Ramp Slope (%)	5.2
Yes	Ramp Width (in)	48.0	No	Ramp XSlope (%)	3.3
N/A	Flare Type LT	N/A	N/A	Flare Type RT	N/A
N/A	Flare Slope LT (%)	N/A	N/A	Flare Slope RT (%)	N/A
N/A	Flare Traversable LT?	N/A	N/A	Flare Traversable RT?	N/A
N/A	Landing Length (in)	N/A	N/A	DWS Provided?	N/A
N/A	Landing Width (in)	N/A	N/A	DWS Contrast?	N/A
N/A	Landing Slope (%)	N/A	N/A	DWS Length (in)	N/A
N/A	Landing X Slope (%)	N/A	N/A	DWS Full Width?	N/A
N/A	Landing Curb? (Y/N)	N/A	N/A	DWS Offset (in)	N/A
N/A	Shared Landing?	N/A			
N/A	Gutter Ponding?	N/A	N/A	Gutter Slope (%)	N/A
N/A	Gutter Lip Ht (in)	1.0	N/A	Gutter X Slope (%)	N/A
N/A	Painted X Walk1?	No	N/A	Painted X Walk2?	N/A
	X Walk 1 Direction	To NW		X Walk 2 Direction	N/A
N/A	X Walk 1 Width (in)	N/A	N/A	X Walk 2 Width (in)	N/A
	X Walk 1 Slope (%)	4.5		X Walk 2 Slope (%)	N/A
	X Walk 1 X Slope (%)	0.1		X Walk 2 X Slope (%)	N/A

N/A	Ramp inside XWalk1?	N/A	N/A	Ramp inside XWalk2?	N/A
	Road Slope (%)	N/A	N/A	Clear Space?	N/A
	Road X Slope (%)	N/A	N/A	Clear Space to XWalk (in)	N/A
N/A	Any Obstructions?	N/A	N/A	Storm Grate/Utility Hazard?	N/A
	Obstruction Type			Storm Grate/Utility Type	
		N/A			N/A
		Yes		Surface Condition? (G/P)	Good

Possible Solutions:

Remove & Replace Entire Ramp.
