# Access Compliance Report

## Public Rights-of-Way

### (Curb Ramps)

Intersection ID: 13763	Main Street: CENTRAL_AV	Cross Street: EASTWAY_DR	Location: NE
ADA ID: A8BF9B1B2988	Ramp Type: Perp	Initial Pass/Fail: Fail	Overall Compliance: No
Severity Score: 8.75			
Codes/Mitigation Info/Possible Solution		Field Measurements/Component Compliance

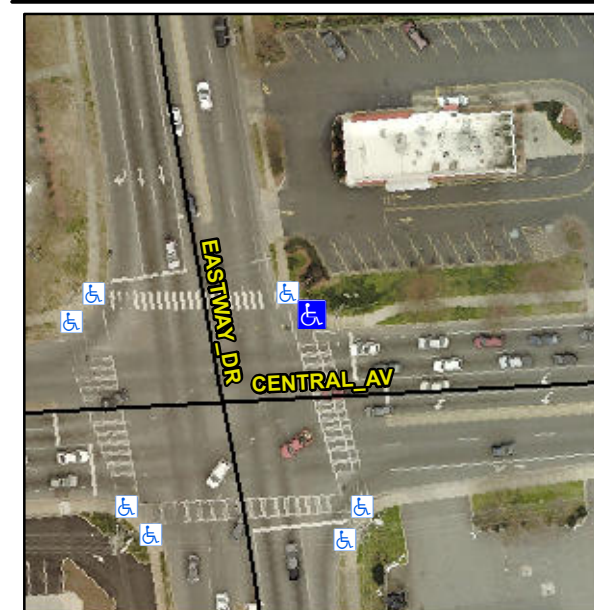
**Not Found, R304.5.1**

Compliance	Description	Data	Compliance	Description	Data
N/A	Ramp Length (in)	71.0	Yes	Ramp Slope (%)	5.2
No	Ramp Width (in)	42.5	Yes	Ramp XSlope (%)	0.9
N/A	Flare Type LT	N/A	N/A	Flare Type RT	N/A
N/A	Flare Slope LT (%)	N/A	N/A	Flare Slope RT (%)	N/A
N/A	Flare Traversable LT?	N/A	N/A	Flare Traversable RT?	N/A
N/A	Landing Length (in)	N/A	N/A	DWS Provided?	N/A
N/A	Landing Width (in)	N/A	N/A	DWS Contrast?	N/A
N/A	Landing Slope (%)	N/A	N/A	DWS Length (in)	N/A
N/A	Landing X Slope (%)	N/A	N/A	DWS Full Width?	N/A
N/A	Landing Curb? (Y/N)	N/A	N/A	DWS Offset (in)	N/A
N/A	Shared Landing?	N/A			
N/A	Gutter Ponding?	N/A	N/A	Gutter Slope (%)	N/A
N/A	Gutter Lip Ht (in)	N/A	N/A	Gutter X Slope (%)	N/A
N/A	Painted X Walk1?	Yes	N/A	Painted X Walk2?	N/A
	X Walk 1 Direction	To S		X Walk 2 Direction	N/A
N/A	X Walk 1 Width (in)	106.0	N/A	X Walk 2 Width (in)	N/A
	X Walk 1 Slope (%)	3.2		X Walk 2 Slope (%)	N/A
	X Walk 1 X Slope (%)	0.7		X Walk 2 X Slope (%)	N/A

N/A	Ramp inside XWalk1?	No	N/A	Ramp inside XWalk2?	N/A
	Road Slope (%)	N/A	N/A	Clear Space?	N/A
	Road X Slope (%)	N/A	N/A	Clear Space to XWalk (in)	N/A
N/A	Any Obstructions?	N/A	N/A	Storm Grate/Utility Hazard?	N/A
	Obstruction Type			Storm Grate/Utility Type	
		N/A			N/A
			Yes	Surface Condition? (G/P)	Good

**Remove & Replace Entire Ramp.  
Restripe Crosswalk.**
