# Access Compliance Report

## Public Rights-of-Way

| Intersection ID: 7084 | Main Street: CEDARHURST_DR | Cross Street: WYNBROOK_WY | Location: SW |
| ADA ID: A8C5AEC82991 | Ramp Type: Perp | Initial Pass/Fail: Fail | Overall Compliance: No |

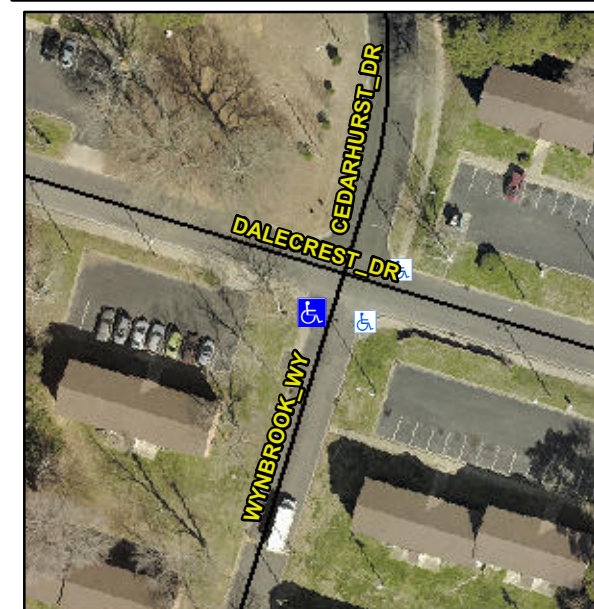
| Severity Score: 33.75 | | | |

**R304.5.1, R304.5.3**

| Compliance | Description | Data | Compliance | Description | Data |
|---|---|---|---|---|---|
| N/A | Ramp Length (in) | 60.0 | Yes | Ramp Slope (%) | 7.1 |
| No | Ramp Width (in) | 36.5 | No | Ramp XSlope (%) | 10.0 |

**Remove & Replace Entire Ramp.**

Total Cost: \$ 1850.00
