# Access Compliance Report

## Public Rights-of-Way

### (Curb Ramps)

Intersection ID: 8045	Main Street: BIRKDALE_DR	Cross Street: S_RAMSEY_ST	Location:	N
ADA ID: A8C8A77F5C5F	Ramp Type: Perp	Initial Pass/Fail: Fail	Overall Compliance: No	Severity Score: 12.5

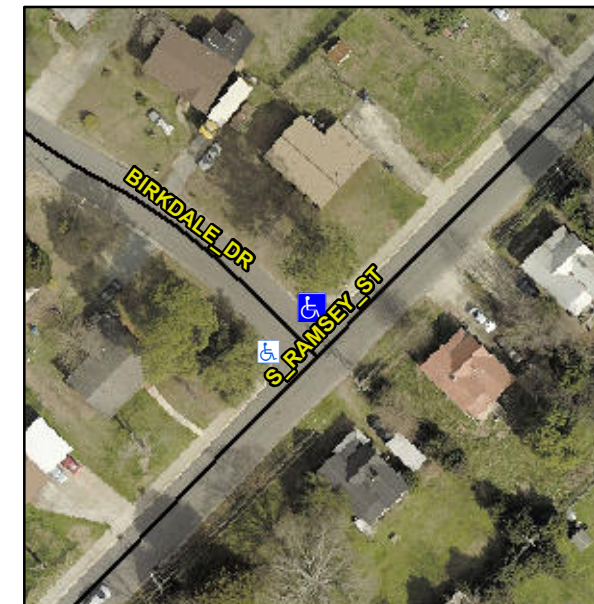
**Not Found, R304.2.2**

Compliance	Description	Data	Compliance	Description	Data
N/A	Ramp Length (in)	51.0	No	Ramp Slope (%)	8.8
Yes	Ramp Width (in)	48.0	Yes	Ramp XSlope (%)	0.8
N/A	Flare Type LT	N/A	N/A	Flare Type RT	N/A
N/A	Flare Slope LT (%)	N/A	N/A	Flare Slope RT (%)	N/A
N/A	Flare Traversable LT?	N/A	N/A	Flare Traversable RT?	N/A
N/A	Landing Length (in)	N/A	N/A	DWS Provided?	N/A
N/A	Landing Width (in)	N/A	N/A	DWS Contrast?	N/A
N/A	Landing Slope (%)	N/A	N/A	DWS Length (in)	N/A
N/A	Landing X Slope (%)	N/A	N/A	DWS Full Width?	N/A
N/A	Landing Curb? (Y/N)	N/A	N/A	DWS Offset (in)	N/A
N/A	Shared Landing?	N/A			
N/A	Gutter Ponding?	N/A	N/A	Gutter Slope (%)	N/A
N/A	Gutter Lip Ht (in)	N/A	N/A	Gutter X Slope (%)	N/A
N/A	Painted X Walk1?	No	N/A	Painted X Walk2?	N/A
	X Walk 1 Direction	To SW		X Walk 2 Direction	N/A
N/A	X Walk 1 Width (in)	N/A	N/A	X Walk 2 Width (in)	N/A
	X Walk 1 Slope (%)	1.7		X Walk 2 Slope (%)	N/A
	X Walk 1 X Slope (%)	1.2		X Walk 2 X Slope (%)	N/A

N/A	Ramp inside XWalk1?	N/A	N/A	Ramp inside XWalk2?	N/A
	Road Slope (%)	N/A	N/A	Clear Space?	N/A
	Road X Slope (%)	N/A	N/A	Clear Space to XWalk (in)	N/A
N/A	Any Obstructions?	N/A	N/A	Storm Grate/Utility Hazard?	N/A
	Obstruction Type			Storm Grate/Utility Type	
		N/A			N/A
			Yes	Surface Condition? (G/P)	Good

**Remove & Replace Entire Ramp.**
