# Access Compliance Report

## Public Rights-of-Way

### (Curb Ramps)

Intersection ID: 31461	Main Street: SENEY_DR	Cross Street: SKIP_STONE_DR	Location: E
ADA ID: A8CD63588C43	Ramp Type: PerpDiag	Initial Pass/Fail: Fail	Overall Compliance: No
Codes/Mitigation Info/Possible Solution		Field Measurements/Component Compliance

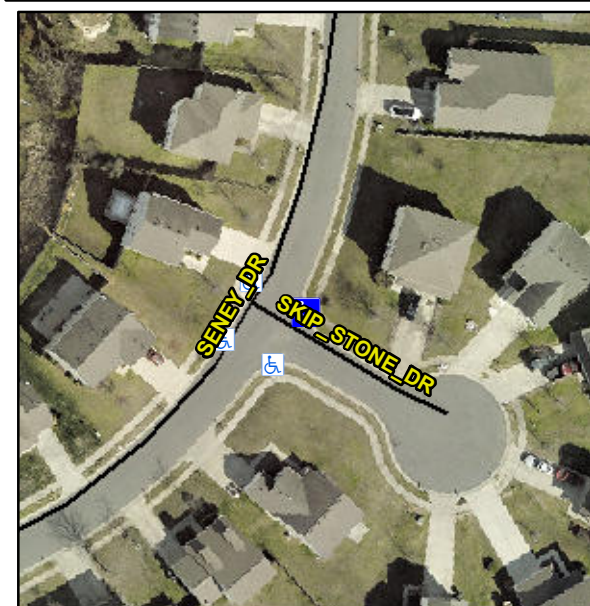
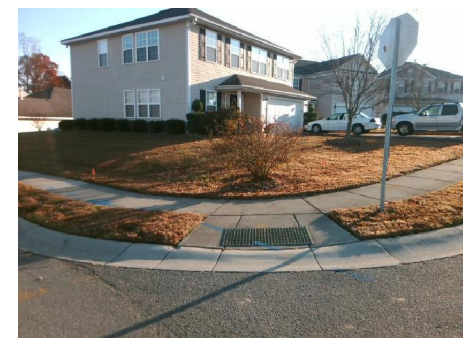
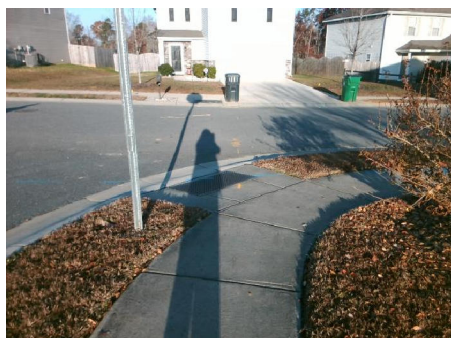
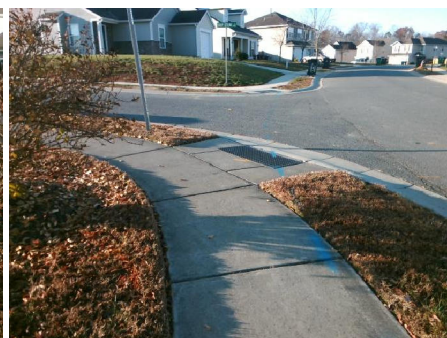
**Not Found, R304.5.1, R304.5.3**

Compliance	Description	Data	Compliance	Description	Data
N/A	Ramp Length (in)	54.0	Yes	Ramp Slope (%)	7.2
No	Ramp Width (in)	33.5	No	Ramp XSlope (%)	4.5
N/A	Flare Type LT	N/A	N/A	Flare Type RT	N/A
N/A	Flare Slope LT (%)	N/A	N/A	Flare Slope RT (%)	N/A
N/A	Flare Traversable LT?	N/A	N/A	Flare Traversable RT?	N/A
N/A	Landing Length (in)	N/A	N/A	DWS Provided?	N/A
N/A	Landing Width (in)	N/A	N/A	DWS Contrast?	N/A
N/A	Landing Slope (%)	N/A	N/A	DWS Length (in)	N/A
N/A	Landing X Slope (%)	N/A	N/A	DWS Full Width?	N/A
N/A	Landing Curb? (Y/N)	N/A	N/A	DWS Offset (in)	N/A
N/A	Shared Landing?	N/A			
N/A	Gutter Ponding?	N/A	N/A	Gutter Slope (%)	N/A
N/A	Gutter Lip Ht (in)	N/A	N/A	Gutter X Slope (%)	N/A
N/A	Painted X Walk1?	No	N/A	Painted X Walk2?	No
	X Walk 1 Direction	To NW		X Walk 2 Direction	To SW
N/A	X Walk 1 Width (in)	N/A	N/A	X Walk 2 Width (in)	N/A
	X Walk 1 Slope (%)	2.9		X Walk 2 Slope (%)	3.4
	X Walk 1 X Slope (%)	3.2		X Walk 2 X Slope (%)	3.7

N/A	Ramp inside XWalk1?	N/A	N/A	Ramp inside XWalk2?	N/A
	Road Slope (%)	2.5	N/A	Clear Space?	N/A
	Road X Slope (%)	0.9	N/A	Clear Space to XWalk (in)	N/A
N/A	Any Obstructions?	N/A	N/A	Storm Grate/Utility Hazard?	N/A
	Obstruction Type			Storm Grate/Utility Type	
		N/A			N/A
			Yes	Surface Condition? (G/P)	Good

Possible Solutions:

**Remove & Replace Curb Ramp With Two New Directional Ramps or Equivalent.**
