Access Compliance Report

Public Rights-of-Way

Intersection ID: 49557	Main Street: STEEL_YARD_CT	Cross Street: WARREN_BURGESS_LN	Location: S
ADA ID: A8CE7534BF87	Ramp Type: BlendTrans1	Initial Pass/Fail: Fail	Overall Compliance: No
		Severity Score: 8.75

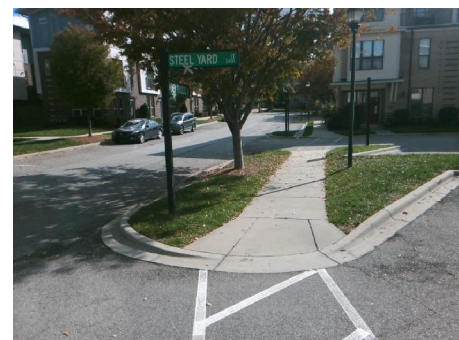
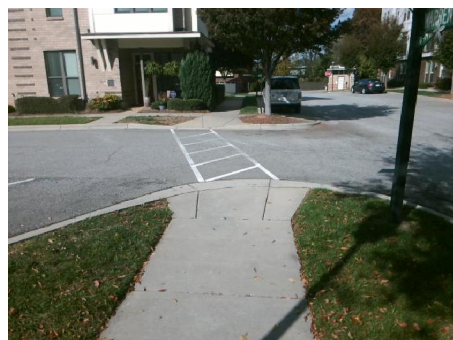
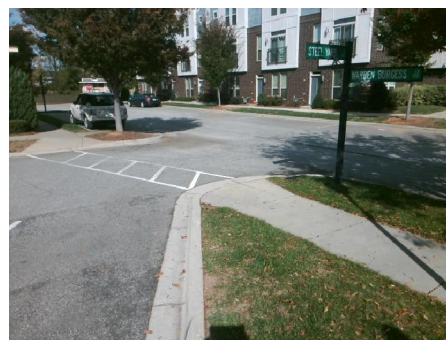
Compliance	Description	Data	Compliance	Description	Data
N/A	Ramp Length (in)	48.0	Yes	BlendTrans Slope (%)	3.4
No	Ramp Width (in)	47.0	Yes	BlendTrans XSlope (%)	1.2
N/A	Flare Type LT	N/A	N/A	Flare Type RT	N/A
N/A	Flare Slope LT (%)	N/A	N/A	Flare Slope RT (%)	N/A
N/A	Flare Traversable LT?	N/A	N/A	Flare Traversable RT?	N/A
N/A	Landing Length (in)	N/A	N/A	DWS Provided?	N/A
N/A	Landing Width (in)	N/A	N/A	DWS Contrast?	N/A
N/A	Landing Slope (%)	N/A	N/A	DWS Length (in)	N/A
N/A	Landing X Slope (%)	N/A	N/A	DWS Full Width?	N/A
N/A	Landing Curb? (Y/N)	N/A	N/A	DWS Offset (in)	N/A
N/A	Shared Landing?	N/A			
N/A	Gutter Ponding?	N/A	N/A	Gutter Slope (%)	N/A
N/A	Gutter Lip Ht (in)	N/A	N/A	Gutter X Slope (%)	N/A
N/A	Painted X Walk1?	Yes	N/A	Painted X Walk2?	N/A
	X Walk 1 Direction	To NW		X Walk 2 Direction	N/A
	X Walk 1 Width (in)	49.0		X Walk 2 Width (in)	N/A
	X Walk 1 Slope (%)	1.0		X Walk 2 Slope (%)	N/A
	X Walk 1 X Slope (%)	1.4		X Walk 2 X Slope (%)	N/A

N/A	Ramp inside XWalk1?	Yes	N/A	Ramp inside XWalk2?	N/A
	Road Slope (%)	1.4		Clear Space?	N/A
	Road X Slope (%)	1.0	N/A	Clear Space to XWalk (in)	N/A
N/A	Any Obstructions?	N/A	N/A	Storm Grate/Utility Hazard?	N/A
	Obstruction Type			Storm Grate/Utility Type	
		N/A			N/A
			Yes	Surface Condition? (G/P)	Good
			N/A	Curb Slope (%)	1.2

Remove & Replace Curb Ramp With Two New Directional Ramps or Equivalent.

R304.5.1
