Access Compliance Report

Public Rights-of-Way

(Curb Ramps)

Intersection ID: 31884	Main Street: CENTERLINE_DR	Cross Street: LIFELINE_LN	Location: SE
ADA ID: A8FAEF7CF110	Ramp Type: PerpDiag	Initial Pass/Fail: Fail	Overall Compliance: No
Codes/Mitigation Info/Possible Solution		Field Measurements/Component Compliance	
Severity Score: 21.25

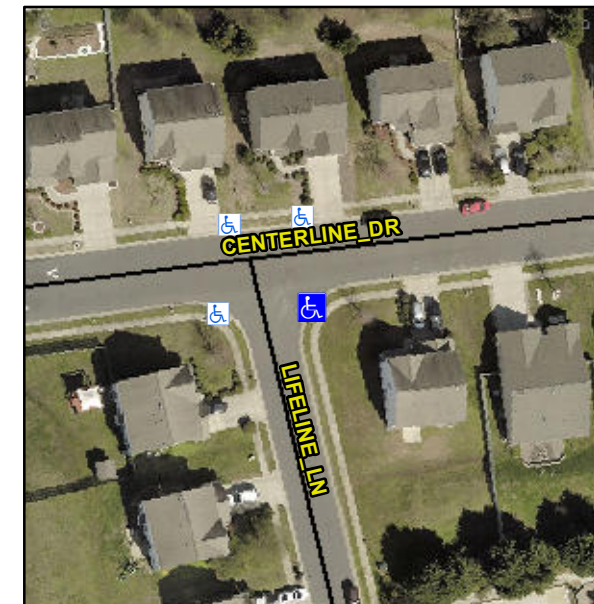
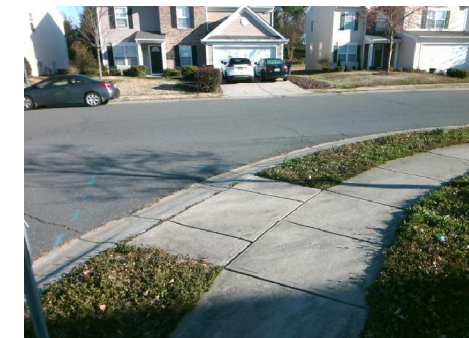
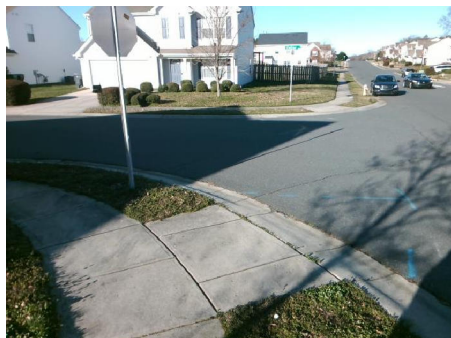
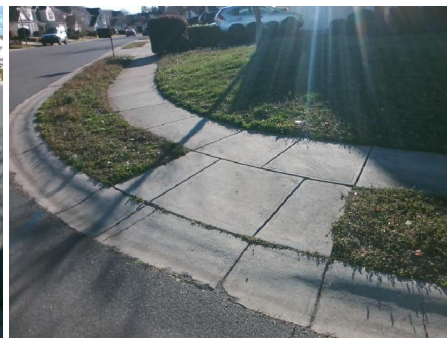
Not Found, R304.5.1, R304.5.3

Compliance	Description	Data	Compliance	Description	Data
N/A	Ramp Length (in)	47.0	Yes	Ramp Slope (%)	5.0
No	Ramp Width (in)	44.5	No	Ramp XSlope (%)	5.9
N/A	Flare Type LT	N/A	N/A	Flare Type RT	N/A
N/A	Flare Slope LT (%)	N/A	N/A	Flare Slope RT (%)	N/A
N/A	Flare Traversable LT?	N/A	N/A	Flare Traversable RT?	N/A
N/A	Landing Length (in)	N/A	N/A	DWS Provided?	N/A
N/A	Landing Width (in)	N/A	N/A	DWS Contrast?	N/A
N/A	Landing Slope (%)	N/A	N/A	DWS Length (in)	N/A
N/A	Landing X Slope (%)	N/A	N/A	DWS Full Width?	N/A
N/A	Landing Curb? (Y/N)	N/A	N/A	DWS Offset (in)	N/A
N/A	Shared Landing?	N/A			
N/A	Gutter Ponding?	N/A	N/A	Gutter Slope (%)	N/A
N/A	Gutter Lip Ht (in)	N/A	N/A	Gutter X Slope (%)	N/A
N/A	Painted X Walk1?	No	N/A	Painted X Walk2?	No
	X Walk 1 Direction	To N		X Walk 2 Direction	To W
N/A	X Walk 1 Width (in)	N/A	N/A	X Walk 2 Width (in)	N/A
	X Walk 1 Slope (%)	3.6		X Walk 2 Slope (%)	1.6
	X Walk 1 X Slope (%)	2.4		X Walk 2 X Slope (%)	2.0

N/A	Ramp inside XWalk1?	N/A	N/A	Ramp inside XWalk2?	N/A
	Road Slope (%)	3.8	N/A	Clear Space?	N/A
	Road X Slope (%)	0.2	N/A	Clear Space to XWalk (in)	N/A
N/A	Any Obstructions?	N/A	N/A	Storm Grate/Utility Hazard?	N/A
	Obstruction Type			Storm Grate/Utility Type	
		N/A			N/A
			Yes	Surface Condition? (G/P)	Good

Remove & Replace Curb Ramp With Two New Directional Ramps or Equivalent.
