Access Compliance Report

Public Rights-of-Way

(Curb Ramps)

Intersection ID: 12040	Main Street: BELVEDERE_AV	Cross Street: THURMOND_PL	Location: NW
ADA ID: A8FB195F27D3	Ramp Type: Para	Initial Pass/Fail: Fail	Overall Compliance: No
Codes/Mitigation Info/Possible Solution			Severity Score: 25
			Field Measurements/Component Compliance

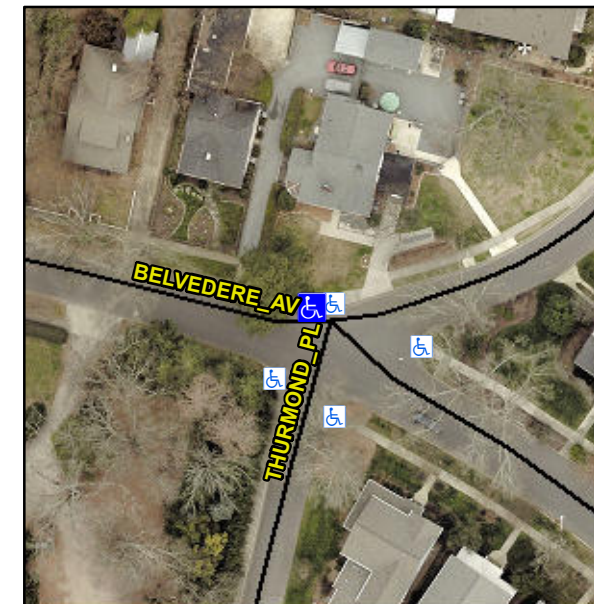
RT RP < 5%

PROW/ADA:

R304.3.2

Compliance	Description	Data	Compliance	Description	Data
N/A	Ramp Length LT (in)	57.0	N/A	Ramp Length RT (in)	34.0
Yes	Ramp Width LT (in)	70.0	Yes	Ramp Width RT (in)	70.0
No	Ramp Slope LT (%)	13.3	Yes	Ramp Slope RT (%)	2.4
Yes	Ramp XSlope LT (%)	0.3	Yes	Ramp XSlope RT (%)	0.1
N/A	Landing Length (in)	N/A	N/A	DWS Provided?	N/A
N/A	Landing Width (in)	N/A	N/A	DWS Contrast?	N/A
N/A	Landing Slope (%)	N/A	N/A	DWS Length (in)	N/A
N/A	Landing X Slope (%)	N/A	N/A	DWS Full Width?	N/A
N/A	Landing Curb? (Y/N)	N/A	N/A	DWS Offset (in)	N/A
N/A	Shared Landing?	N/A			
N/A	Gutter Ponding?	N/A	N/A	Gutter Slope (%)	N/A
N/A	Gutter Lip Ht (in)	N/A	N/A	Gutter X Slope (%)	N/A
N/A	Painted X Walk1?	No	N/A	Painted X Walk2?	N/A
	X Walk 1 Direction	To SW		X Walk 2 Direction	N/A
N/A	X Walk 1 Width (in)	N/A	N/A	X Walk 2 Width (in)	N/A
	X Walk 1 Slope (%)	3.4		X Walk 2 Slope (%)	N/A
	X Walk 1 X Slope (%)	2.4		X Walk 2 X Slope (%)	N/A
N/A	Ramp inside XWalk1?	N/A	N/A	Ramp inside XWalk2?	N/A

Road Slope (%)	N/A	N/A	Clear Space?	N/A
	Road X Slope (%)	N/A	N/A	Clear Space to XWalk (in)	N/A
N/A	Any Obstructions?	N/A	N/A	Storm Grate/Utility Hazard?	N/A
	Obstruction Type			Storm Grate/Utility Type	
		N/A			N/A
			Yes	Surface Condition? (G/P)	Good
			N/A	Curb Slope (%)	19.0

Possible Solutions:

Remove & Replace Entire Ramp.
