Access Compliance Report

Public Rights-of-Way

(Curb Ramps)

Intersection ID: 5162	Main Street: BROOKFIELD_POINTE_DR	Cross Street: SUNSET_RD	Location:	W
ADA ID: A9021CFF1FF5	Ramp Type: Perp	Initial Pass/Fail: Fail	Overall Compliance: No	Severity Score: 22.5
Codes/Mitigation Info/Possible Solution		Field Measurements/Component Compliance

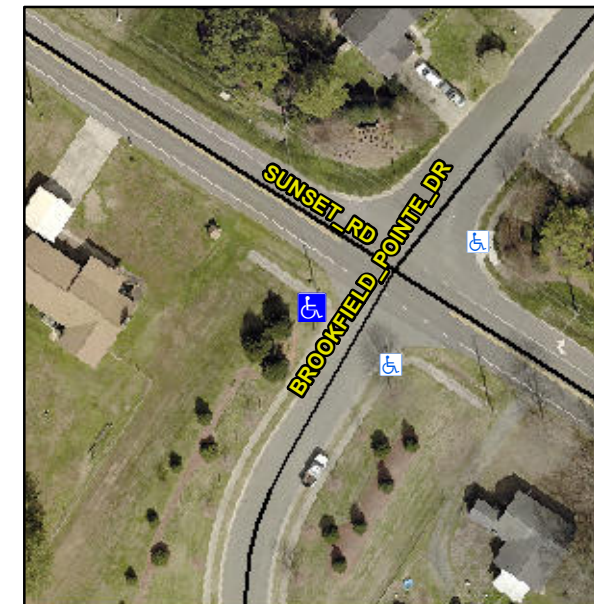
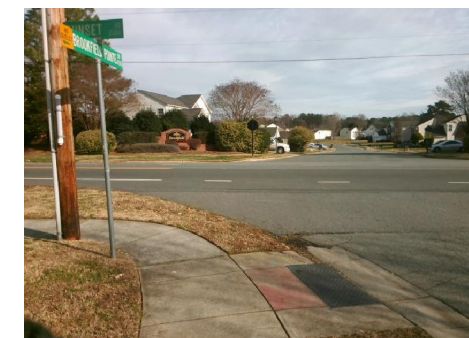
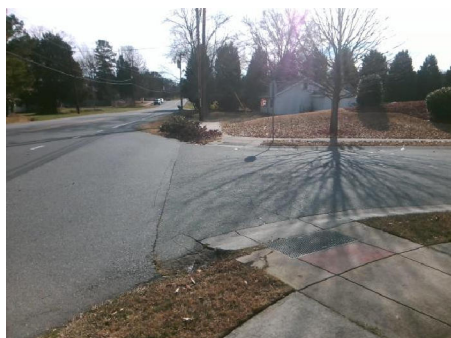
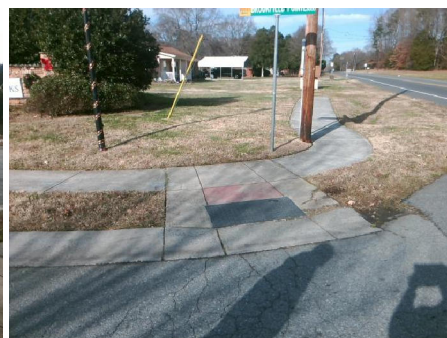
Not Found, R304.5.1, R304.2.2, R304.5.3

Compliance	Description	Data	Compliance	Description	Data
N/A	Ramp Length (in)	48.0	No	Ramp Slope (%)	8.8
No	Ramp Width (in)	41.5	No	Ramp XSlope (%)	2.4
N/A	Flare Type LT	N/A	N/A	Flare Type RT	N/A
N/A	Flare Slope LT (%)	N/A	N/A	Flare Slope RT (%)	N/A
N/A	Flare Traversable LT?	N/A	N/A	Flare Traversable RT?	N/A
N/A	Landing Length (in)	N/A	N/A	DWS Provided?	N/A
N/A	Landing Width (in)	N/A	N/A	DWS Contrast?	N/A
N/A	Landing Slope (%)	N/A	N/A	DWS Length (in)	N/A
N/A	Landing X Slope (%)	N/A	N/A	DWS Full Width?	N/A
N/A	Landing Curb? (Y/N)	N/A	N/A	DWS Offset (in)	N/A
N/A	Shared Landing?	N/A			
N/A	Gutter Ponding?	N/A	N/A	Gutter Slope (%)	N/A
N/A	Gutter Lip Ht (in)	N/A	N/A	Gutter X Slope (%)	N/A
N/A	Painted X Walk1?	No	N/A	Painted X Walk2?	N/A
	X Walk 1 Direction	To SE		X Walk 2 Direction	N/A
N/A	X Walk 1 Width (in)	N/A	N/A	X Walk 2 Width (in)	N/A
	X Walk 1 Slope (%)	2.5		X Walk 2 Slope (%)	N/A
	X Walk 1 X Slope (%)	4.2		X Walk 2 X Slope (%)	N/A

N/A	Ramp inside XWalk1?	N/A	N/A	Ramp inside XWalk2?	N/A
	Road Slope (%)	N/A	N/A	Clear Space?	N/A
	Road X Slope (%)	N/A	N/A	Clear Space to XWalk (in)	N/A
N/A	Any Obstructions?	N/A	N/A	Storm Grate/Utility Hazard?	N/A
	Obstruction Type			Storm Grate/Utility Type	
		N/A			N/A
			Yes	Surface Condition? (G/P)	Good

Remove & Replace Entire Ramp.

Total Cost: \$ 1850.00
