# Access Compliance Report

### (Curb Ramps)

| Intersection ID: 22484 | Main Street: RIVER_OAKS_LN | Cross Street: SHARON_VIEW_RD | Location: NW |
| ADA ID: A906B344D43B | Ramp Type: PerpDiag | Initial Pass/Fail: Fail | Overall Compliance: No |

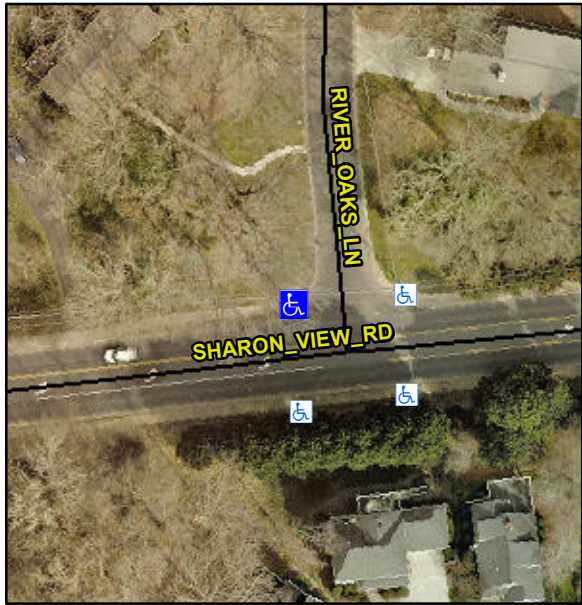
| Codes/Mitigation Info/Possible Solution | | | Field Measurements/Component Compliance | | | | | |
|--|---|---|---|---|---|---|---|---|
| | <b>Remove &amp; Replace Curb Ramp With Two New Directional Ramps or Equivalent.</b> | | N/A | Ramp Length (in) | 108.0 | Yes | Ramp Slope (%) | 5.8 |
| | | | No | Ramp Width (in) | 34.0 | No | Ramp XSlope (%) | 4.1 |
| PROW/ADA: | | Not Found, R304.5.1, R304.5.3 | N/A | Shared Landing? | N/A | | | |
