# Access Compliance Report

## Public Rights-of-Way

### (Curb Ramps)

| Intersection ID: 49656 | Main Street: SKYLINE_VIEW_WY | Cross Street: SEIGLE_POINT_DR | Location: SW |

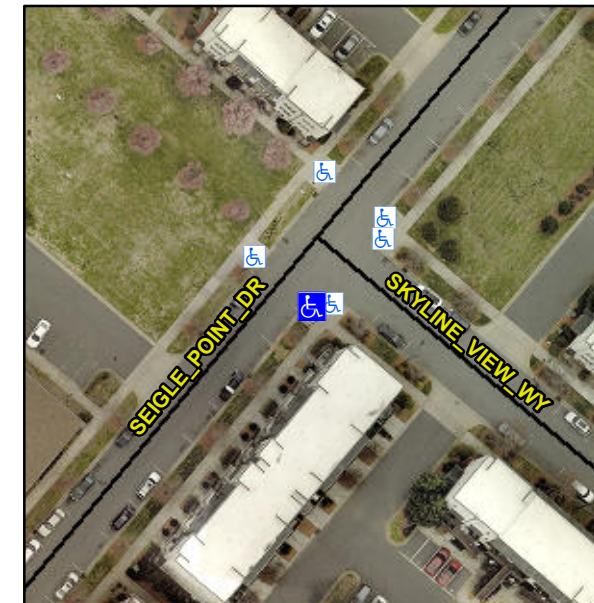
**R304.5.3, R302.7, R304.5.4**

| Compliance | Description | Data | Compliance | Description | Data |
|---|---|---|---|---|---|
| No | Landing X Slope (%) | 2.6 | Yes | DWS Full Width? | Yes |
| No | Gutter Ponding? | Yes | No | Gutter Slope (%) | 5.3 |

**Remove & Replace Landing.  
Remove & Replace Gutter.**
