# Access Compliance Report

## Public Rights-of-Way

| Intersection ID: 50099 | Main Street: SUNRISE_VIEW_DR | Cross Street: GRIERS_PASTURE_DR | Location: SE |
| ADA ID: A9128E246307 | Ramp Type: Perp | Initial Pass/Fail: Fail | Overall Compliance: No |

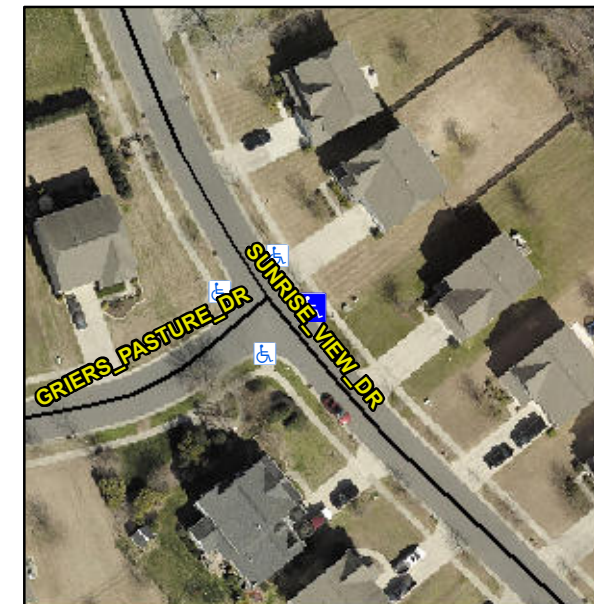
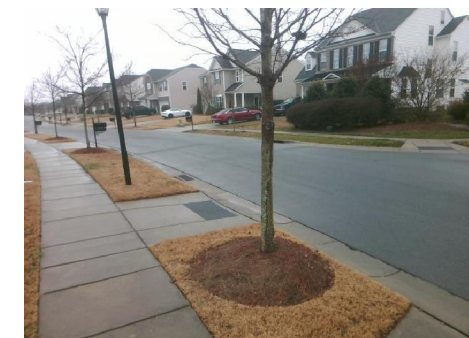
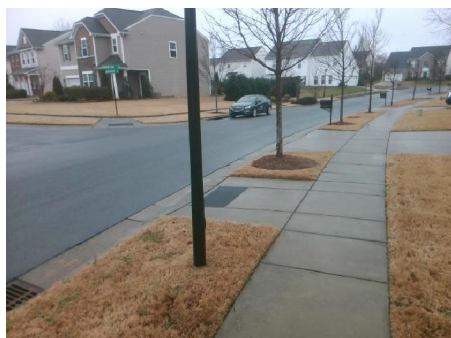
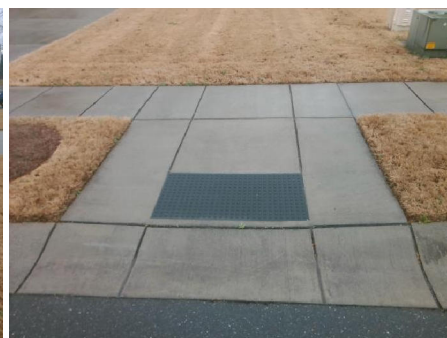
**Not Found, R304.5.1, R304.5.3**

| Compliance | Description | Data | Compliance | Description | Data |
|---|---|---|---|---|---|
| N/A | Ramp Length (in) | 72.0 | Yes | Ramp Slope (%) | 7.0 |
| No | Ramp Width (in) | 46.5 | No | Ramp XSlope (%) | 3.7 |
| | | | Yes | Surface Condition? (G/P) | Good |

**Remove & Replace Entire Ramp.**

Total Cost: \$ 1850.00
