Access Compliance Report

Public Rights-of-Way

(Curb Ramps)

Intersection ID: 49277	Main Street: REUNION_ST	Cross Street: HOMECOMING_WY	Location: NW
ADA ID: A91D7743D8F6	Ramp Type: Perp	Initial Pass/Fail: Fail	Overall Compliance: No
Severity Score: 13.75			
Codes/Mitigation Info/Possible Solution		Field Measurements/Component Compliance

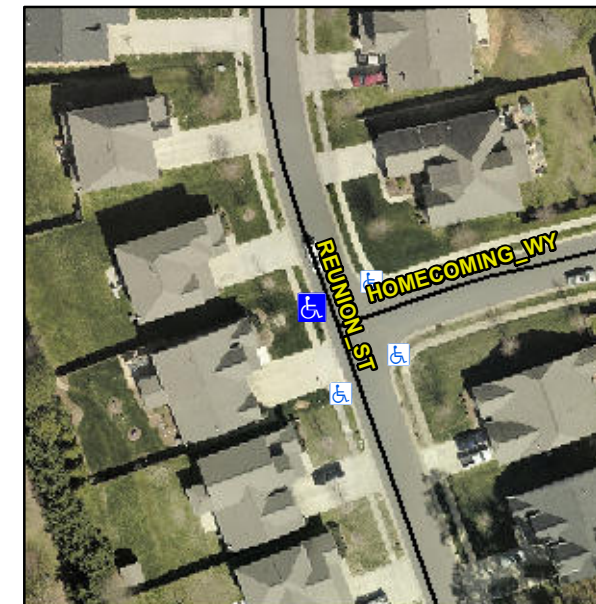
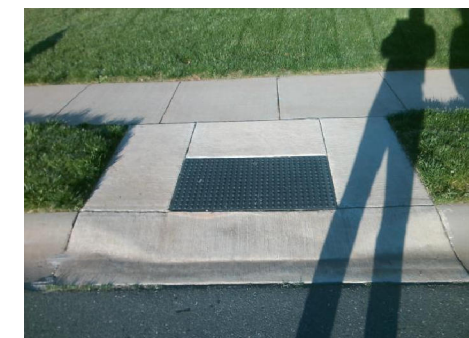
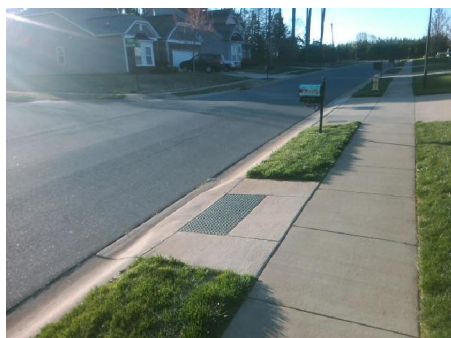
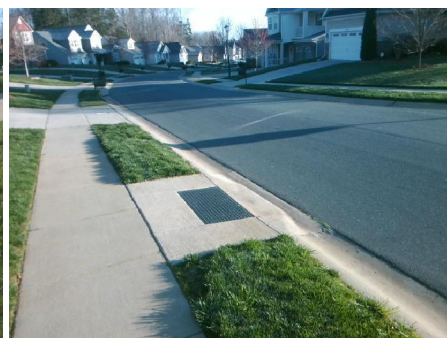
Not Found, R304.2.2, R304.5.3

Compliance	Description	Data	Compliance	Description	Data
N/A	Ramp Length (in)	49.0	No	Ramp Slope (%)	9.7
Yes	Ramp Width (in)	48.0	No	Ramp XSlope (%)	3.2
N/A	Flare Type LT	N/A	N/A	Flare Type RT	N/A
N/A	Flare Slope LT (%)	N/A	N/A	Flare Slope RT (%)	N/A
N/A	Flare Traversable LT?	N/A	N/A	Flare Traversable RT?	N/A
N/A	Landing Length (in)	N/A	N/A	DWS Provided?	N/A
N/A	Landing Width (in)	N/A	N/A	DWS Contrast?	N/A
N/A	Landing Slope (%)	N/A	N/A	DWS Length (in)	N/A
N/A	Landing X Slope (%)	N/A	N/A	DWS Full Width?	N/A
N/A	Landing Curb? (Y/N)	N/A	N/A	DWS Offset (in)	N/A
N/A	Shared Landing?	N/A			
N/A	Gutter Ponding?	N/A	N/A	Gutter Slope (%)	N/A
N/A	Gutter Lip Ht (in)	N/A	N/A	Gutter X Slope (%)	N/A
N/A	Painted X Walk1?	No	N/A	Painted X Walk2?	N/A
	X Walk 1 Direction	To E		X Walk 2 Direction	N/A
N/A	X Walk 1 Width (in)	N/A	N/A	X Walk 2 Width (in)	N/A
	X Walk 1 Slope (%)	3.5		X Walk 2 Slope (%)	N/A
	X Walk 1 X Slope (%)	3.0		X Walk 2 X Slope (%)	N/A

N/A	Ramp inside XWalk1?	N/A	N/A	Ramp inside XWalk2?	N/A
	Road Slope (%)	N/A	N/A	Clear Space?	N/A
	Road X Slope (%)	N/A	N/A	Clear Space to XWalk (in)	N/A
N/A	Any Obstructions?	N/A	N/A	Storm Grate/Utility Hazard?	N/A
	Obstruction Type			Storm Grate/Utility Type	
		N/A			N/A
		Yes		Surface Condition? (G/P)	Good

Possible Solutions:

Remove & Replace Entire Ramp.
