## **Access Compliance Report Public Rights-of-Way** (Curb Ramps)

Intersection ID: 43744 Main Street: RED CLAY LN Cross Street: EARTHENWARE DR Location: N **Overall Compliance: No Severity Score:** 35 ADA ID: A930626EA863 Ramp Type: PerpDiag Initial Pass/Fail: Fail

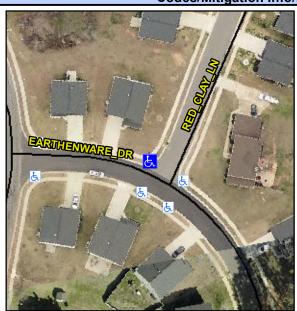
Ramp Slope (%)

Ramp XSlope (%)

48.0

47.0

Not Found, R304.5.1, R304.2.2, R304.5.3

**EARTHENWARE DR** Street 1 Name Stop Condition-Street 2 **RED CLAY LN** Street 2 Name Stop Condition-Street 1 StopSign Remove & Replace Curb Ramp With Two New Directional Ramps or Equivalent.
