Access Compliance Report

Public Rights-of-Way

(Curb Ramps)

Intersection ID: 10038639	Main Street: ST_JOHN_LN	Cross Street: N/A	Location:	N
ADA ID: A935D14C5119	Ramp Type: BlendTrans1	Initial Pass/Fail: Fail	Overall Compliance: No	Severity Score: 8.75
Codes/Mitigation Info/Possible Solution		Field Measurements/Component Compliance

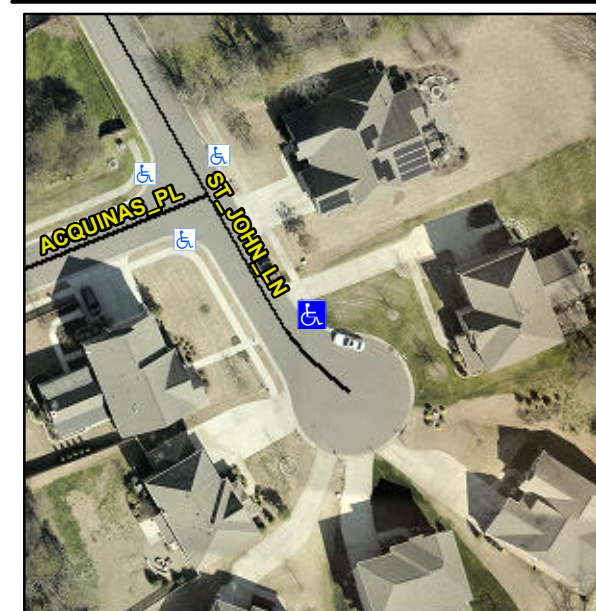
CURB LIP 0.5

Not Found, R304.5.1

Compliance	Description	Data	Compliance	Description	Data
N/A	Ramp Length (in)	47.0	Yes	BlendTrans Slope (%)	3.8
No	Ramp Width (in)	47.0	Yes	BlendTrans XSlope (%)	1.8
N/A	Flare Type LT	N/A	N/A	Flare Type RT	N/A
N/A	Flare Slope LT (%)	N/A	N/A	Flare Slope RT (%)	N/A
N/A	Flare Traversable LT?	N/A	N/A	Flare Traversable RT?	N/A
N/A	Landing Length (in)	N/A	N/A	DWS Provided?	N/A
N/A	Landing Width (in)	N/A	N/A	DWS Contrast?	N/A
N/A	Landing Slope (%)	N/A	N/A	DWS Length (in)	N/A
N/A	Landing X Slope (%)	N/A	N/A	DWS Full Width?	N/A
N/A	Landing Curb? (Y/N)	N/A	N/A	DWS Offset (in)	N/A
N/A	Shared Landing?	N/A			
N/A	Gutter Ponding?	N/A	N/A	Gutter Slope (%)	N/A
N/A	Gutter Lip Ht (in)	N/A	N/A	Gutter X Slope (%)	N/A
N/A	Painted X Walk1?	No	N/A	Painted X Walk2?	N/A
	X Walk 1 Direction	To SW		X Walk 2 Direction	N/A
	X Walk 1 Width (in)	N/A		X Walk 2 Width (in)	N/A
	X Walk 1 Slope (%)	2.6		X Walk 2 Slope (%)	N/A
	X Walk 1 X Slope (%)	3.4		X Walk 2 X Slope (%)	N/A

N/A	Ramp inside XWalk1?	N/A	N/A	Ramp inside XWalk2?	N/A
	Road Slope (%)	3.4		Clear Space?	N/A
	Road X Slope (%)	2.6	N/A	Clear Space to XWalk (in)	N/A
N/A	Any Obstructions?	N/A	N/A	Storm Grate/Utility Hazard?	N/A
	Obstruction Type			Storm Grate/Utility Type	
		N/A			N/A
			Yes	Surface Condition? (G/P)	Good
			No	Curb Slope (%)	11.6

Remove & Replace Curb Ramp With Two New Directional Ramps or Equivalent.

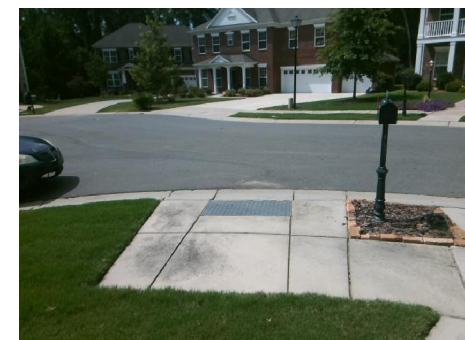
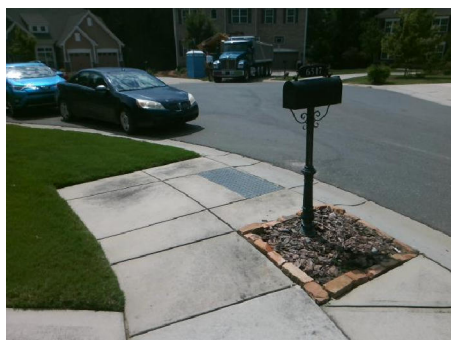
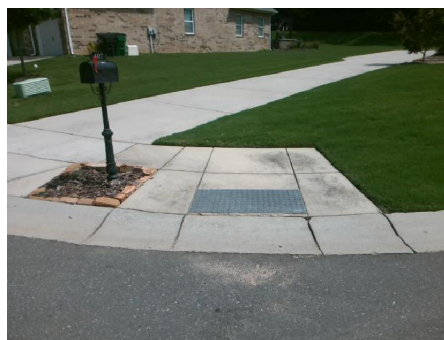
Street 1 Name ST JOHN LN
 Stop Condition-Street 1 None
 Street 2 Name N/A
 Stop Condition-Street 2 N/A
