Access Compliance Report

Public Rights-of-Way

(Curb Ramps)

Intersection ID: 19258	Main Street: MARION_DIEHL_PARK_DR	Cross Street: TYVOLA_RD	Location: NW
ADA ID: A9384614A33E	Ramp Type: Directional2	Initial Pass/Fail: Fail	Overall Compliance: No
		Severity Score: 30

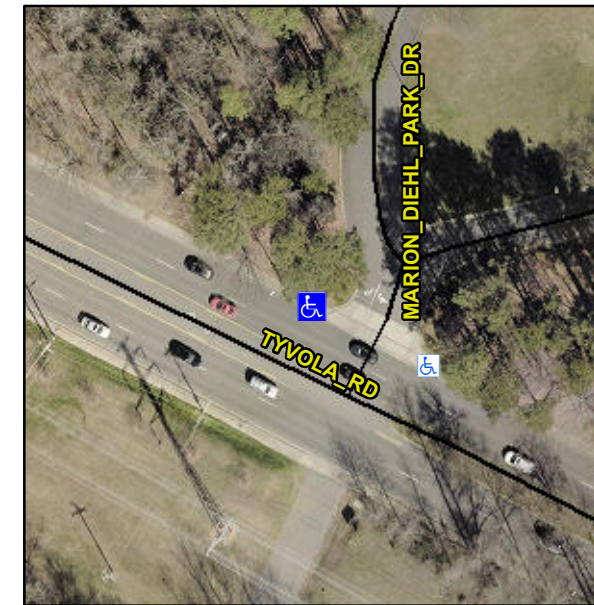
R304.5.1, R304.5.3

Compliance	Description	Data	Compliance	Description	Data
N/A	Ramp Length (in)	109.0	N/A	Grade Break?	N/A
No	Ramp Width (in)	33.0	N/A	Grade Break Slope (%)	0.0
Yes	Ramp Slope (%)	1.2	N/A	Grade Break XSlope (%)	0.0
No	Ramp XSlope (%)	6.7			
N/A	Flare Type LT	N/A	N/A	Flare Type RT	N/A
N/A	Flare Slope LT (%)	N/A	N/A	Flare Slope RT (%)	0.0
N/A	Flare Traversable LT?	N/A	N/A	Flare Traversable RT?	N/A
N/A	Landing Length (in)	0.0	N/A	DWS Provided?	N/A
N/A	Landing Width (in)	0.0	N/A	DWS Contrast?	N/A
N/A	Landing Slope (%)	0.0	N/A	DWS Length (in)	N/A
N/A	Landing X Slope (%)	0.0	N/A	DWS Full Width?	N/A
N/A	Landing Curb? (Y/N)	N/A	N/A	DWS Offset LT (in)	N/A
N/A	Shared Landing?	N/A	N/A	DWS Offset RT (in)	N/A
N/A	Gutter Ponding?	0.0	N/A	Gutter Slope (%)	N/A
N/A	Gutter Lip Ht (in)	0.0	N/A	Gutter X Slope (%)	N/A
N/A	Painted X Walk1?	No		Road Slope (%)	3.0
	X Walk 1 Direction	To E		Road X Slope (%)	11.6
	X Walk 1 Width (in)	N/A		Clear Space?	N/A

X Walk 1 Slope (%)	3.0	N/A	Clear Space to XWalk (in)	N/A
	X Walk 1 X Slope (%)	11.6	N/A	Storm Grate/Utility Hazard?	N/A
N/A	Ramp inside XWalk1?	N/A		Storm Grate/Utility Type	
N/A	Any Obstructions?	N/A			N/A
	Obstruction Type		Yes	Surface Condition? (G/P)	Good
			N/A	Curb Slope (%)	11.2

Remove & Replace Entire Ramp.
