Access Compliance Report

Public Rights-of-Way

(Curb Ramps)

Intersection ID: 10844	Main Street: W_5TH_ST	Cross Street: FRAZIER_AV	Location: E
ADA ID: A93C094DA73D	Ramp Type: PerpDiag	Initial Pass/Fail: Fail	Overall Compliance: No
Severity Score: 46.25			
Codes/Mitigation Info/Possible Solution		Field Measurements/Component Compliance

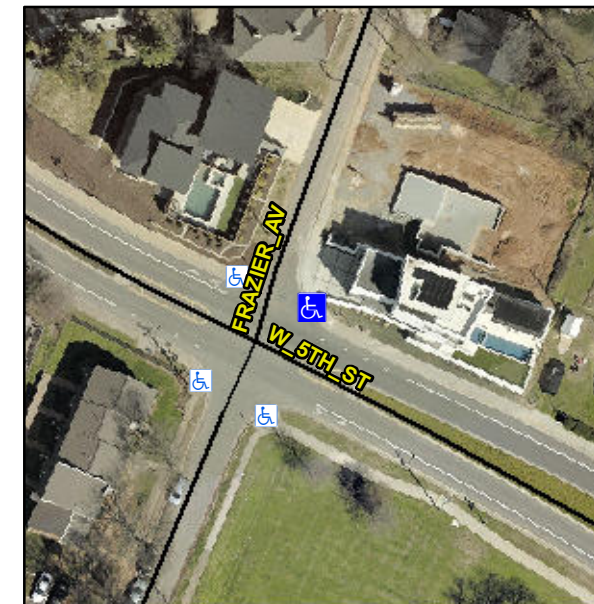
Not Found, R304.5.1, R304.2.2, R304.5.3

Compliance	Description	Data	Compliance	Description	Data
N/A	Ramp Length (in)	57.0	No	Ramp Slope (%)	8.4
No	Ramp Width (in)	47.5	No	Ramp XSlope (%)	10.5
N/A	Flare Type LT	N/A	N/A	Flare Type RT	N/A
N/A	Flare Slope LT (%)	N/A	N/A	Flare Slope RT (%)	N/A
N/A	Flare Traversable LT?	N/A	N/A	Flare Traversable RT?	N/A
N/A	Landing Length (in)	N/A	N/A	DWS Provided?	N/A
N/A	Landing Width (in)	N/A	N/A	DWS Contrast?	N/A
N/A	Landing Slope (%)	N/A	N/A	DWS Length (in)	N/A
N/A	Landing X Slope (%)	N/A	N/A	DWS Full Width?	N/A
N/A	Landing Curb? (Y/N)	N/A	N/A	DWS Offset (in)	N/A
N/A	Shared Landing?	N/A			
N/A	Gutter Ponding?	N/A	N/A	Gutter Slope (%)	N/A
N/A	Gutter Lip Ht (in)	N/A	N/A	Gutter X Slope (%)	N/A
N/A	Painted X Walk1?	No	N/A	Painted X Walk2?	No
	X Walk 1 Direction	To NW		X Walk 2 Direction	To SW
N/A	X Walk 1 Width (in)	N/A	N/A	X Walk 2 Width (in)	N/A
	X Walk 1 Slope (%)	8.7		X Walk 2 Slope (%)	0.6
	X Walk 1 X Slope (%)	5.0		X Walk 2 X Slope (%)	10.0

N/A	Ramp inside XWalk1?	N/A	N/A	Ramp inside XWalk2?	N/A
	Road Slope (%)	9.6	N/A	Clear Space?	N/A
	Road X Slope (%)	4.9	N/A	Clear Space to XWalk (in)	N/A
N/A	Any Obstructions?	N/A	N/A	Storm Grate/Utility Hazard?	N/A
	Obstruction Type			Storm Grate/Utility Type	
		N/A			N/A
			Yes	Surface Condition? (G/P)	Good

Possible Solutions:

Remove & Replace Curb Ramp With Two New Directional Ramps or Equivalent.
