Access Compliance Report

Public Rights-of-Way

(Curb Ramps)

Intersection ID: 3590	Main Street: SANDRINGHAM_PL	Cross Street: WEAVERS_GLENN_PL	Location:	N
ADA ID: A94205597FE2	Ramp Type: Perp	Initial Pass/Fail: Fail	Overall Compliance: No	Severity Score: 1.25
Codes/Mitigation Info/Possible Solution		Field Measurements/Component Compliance

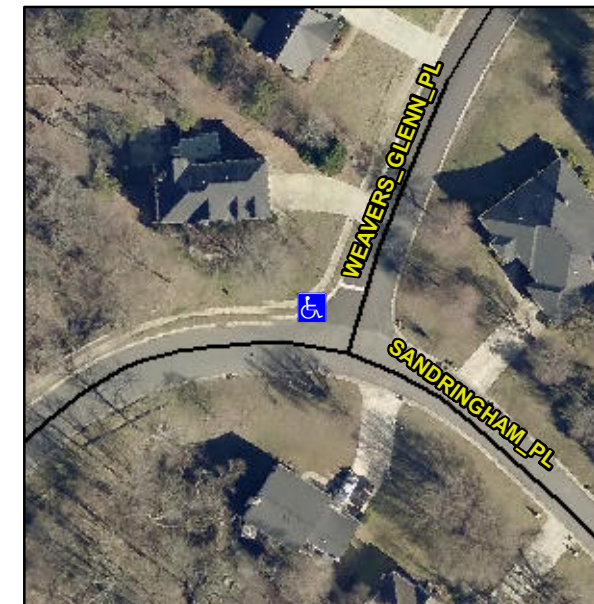
Not Found, R304.5.3

Compliance	Description	Data	Compliance	Description	Data
N/A	Ramp Length (in)	48.0	Yes	Ramp Slope (%)	5.0
Yes	Ramp Width (in)	52.0	No	Ramp XSlope (%)	3.5
N/A	Flare Type LT	N/A	N/A	Flare Type RT	N/A
N/A	Flare Slope LT (%)	N/A	N/A	Flare Slope RT (%)	N/A
N/A	Flare Traversable LT?	N/A	N/A	Flare Traversable RT?	N/A
N/A	Landing Length (in)	N/A	N/A	DWS Provided?	N/A
N/A	Landing Width (in)	N/A	N/A	DWS Contrast?	N/A
N/A	Landing Slope (%)	N/A	N/A	DWS Length (in)	N/A
N/A	Landing X Slope (%)	N/A	N/A	DWS Full Width?	N/A
N/A	Landing Curb? (Y/N)	N/A	N/A	DWS Offset (in)	N/A
N/A	Shared Landing?	N/A			
N/A	Gutter Ponding?	N/A	N/A	Gutter Slope (%)	N/A
N/A	Gutter Lip Ht (in)	N/A	N/A	Gutter X Slope (%)	N/A
N/A	Painted X Walk1?	No	N/A	Painted X Walk2?	N/A
	X Walk 1 Direction	To SW		X Walk 2 Direction	N/A
N/A	X Walk 1 Width (in)	N/A	N/A	X Walk 2 Width (in)	N/A
	X Walk 1 Slope (%)	1.1		X Walk 2 Slope (%)	N/A
	X Walk 1 X Slope (%)	2.7		X Walk 2 X Slope (%)	N/A

N/A	Ramp inside XWalk1?	N/A	N/A	Ramp inside XWalk2?	N/A
	Road Slope (%)	N/A	N/A	Clear Space?	N/A
	Road X Slope (%)	N/A	N/A	Clear Space to XWalk (in)	N/A
N/A	Any Obstructions?	N/A	N/A	Storm Grate/Utility Hazard?	N/A
	Obstruction Type			Storm Grate/Utility Type	
		N/A			N/A
			Yes	Surface Condition? (G/P)	Good

Possible Solutions:

Remove & Replace Entire Ramp.
