Access Compliance Report

Public Rights-of-Way

(Curb Ramps)

Intersection ID: 19993	Main Street: ARCHDALE_DR	Cross Street: INGLESIDE_DR	Location: SW
ADA ID: A946E0DCF9D2	Ramp Type: PerpDiag	Initial Pass/Fail: Fail	Overall Compliance: No
		Severity Score: 10

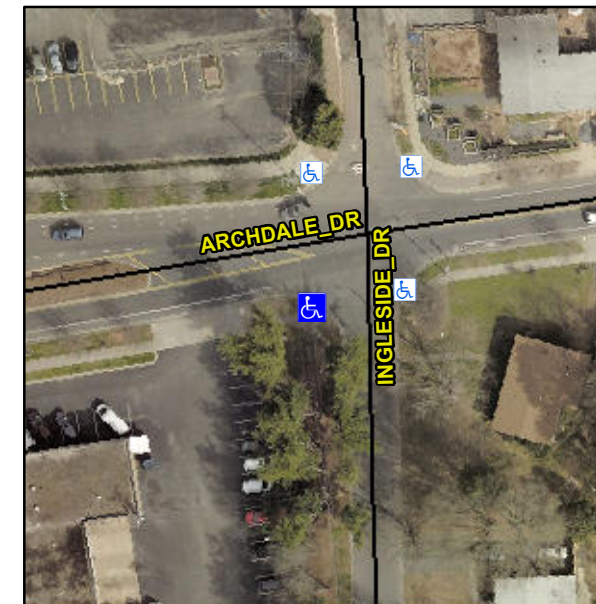
Not Found, R304.5.1, R304.5.3

Compliance	Description	Data	Compliance	Description	Data
N/A	Ramp Length (in)	96.0	Yes	Ramp Slope (%)	7.8
No	Ramp Width (in)	46.0	No	Ramp XSlope (%)	2.1
N/A	Flare Type LT	N/A	N/A	Flare Type RT	N/A
N/A	Flare Slope LT (%)	N/A	N/A	Flare Slope RT (%)	N/A
N/A	Flare Traversable LT?	N/A	N/A	Flare Traversable RT?	N/A
N/A	Landing Length (in)	N/A	N/A	DWS Provided?	N/A
N/A	Landing Width (in)	N/A	N/A	DWS Contrast?	N/A
N/A	Landing Slope (%)	N/A	N/A	DWS Length (in)	N/A
N/A	Landing X Slope (%)	N/A	N/A	DWS Full Width?	N/A
N/A	Landing Curb? (Y/N)	N/A	N/A	DWS Offset (in)	N/A
N/A	Shared Landing?	N/A			
N/A	Gutter Ponding?	N/A	N/A	Gutter Slope (%)	N/A
N/A	Gutter Lip Ht (in)	N/A	N/A	Gutter X Slope (%)	N/A
N/A	Painted X Walk1?	No	N/A	Painted X Walk2?	No
	X Walk 1 Direction	To E		X Walk 2 Direction	To N
N/A	X Walk 1 Width (in)	N/A	N/A	X Walk 2 Width (in)	N/A
	X Walk 1 Slope (%)	2.8		X Walk 2 Slope (%)	1.1
	X Walk 1 X Slope (%)	1.6		X Walk 2 X Slope (%)	1.9

N/A	Ramp inside XWalk1?	N/A	N/A	Ramp inside XWalk2?	N/A
	Road Slope (%)	0.6	N/A	Clear Space?	N/A
	Road X Slope (%)	2.6	N/A	Clear Space to XWalk (in)	N/A
N/A	Any Obstructions?	N/A	N/A	Storm Grate/Utility Hazard?	N/A
	Obstruction Type			Storm Grate/Utility Type	
		N/A			N/A
			Yes	Surface Condition? (G/P)	Good

Remove & Replace Curb Ramp With Two New Directional Ramps or Equivalent.
