Access Compliance Report

Public Rights-of-Way

(Curb Ramps)

Intersection ID: 13390	Main Street: W_KINGSTON_AV	Cross Street: WILMORE_DR	Location: NE
ADA ID: A94F30D0D6A4	Ramp Type: PerpDiag	Initial Pass/Fail: Fail	Overall Compliance: No
		Severity Score: 37.5

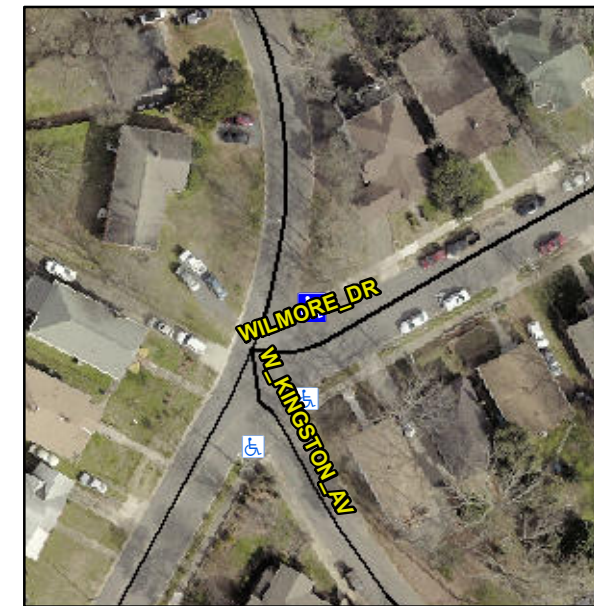
Not Found, R304.2.2, R304.5.3

Compliance	Description	Data	Compliance	Description	Data
N/A	Ramp Length (in)	72.0	No	Ramp Slope (%)	9.9
Yes	Ramp Width (in)	68.0	No	Ramp XSlope (%)	8.0
N/A	Flare Type LT	N/A	N/A	Flare Type RT	N/A
N/A	Flare Slope LT (%)	N/A	N/A	Flare Slope RT (%)	N/A
N/A	Flare Traversable LT?	N/A	N/A	Flare Traversable RT?	N/A
N/A	Landing Length (in)	N/A	N/A	DWS Provided?	N/A
N/A	Landing Width (in)	N/A	N/A	DWS Contrast?	N/A
N/A	Landing Slope (%)	N/A	N/A	DWS Length (in)	N/A
N/A	Landing X Slope (%)	N/A	N/A	DWS Full Width?	N/A
N/A	Landing Curb? (Y/N)	N/A	N/A	DWS Offset (in)	N/A
N/A	Shared Landing?	N/A			
N/A	Gutter Ponding?	N/A	N/A	Gutter Slope (%)	N/A
N/A	Gutter Lip Ht (in)	N/A	N/A	Gutter X Slope (%)	N/A
N/A	Painted X Walk1?	No	N/A	Painted X Walk2?	No
	X Walk 1 Direction	To NW		X Walk 2 Direction	To SW
N/A	X Walk 1 Width (in)	N/A	N/A	X Walk 2 Width (in)	N/A
	X Walk 1 Slope (%)	1.6		X Walk 2 Slope (%)	5.1
	X Walk 1 X Slope (%)	2.4		X Walk 2 X Slope (%)	4.9

N/A	Ramp inside XWalk1?	N/A	N/A	Ramp inside XWalk2?	N/A
	Road Slope (%)	5.4	N/A	Clear Space?	N/A
	Road X Slope (%)	2.0	N/A	Clear Space to XWalk (in)	N/A
N/A	Any Obstructions?	N/A	N/A	Storm Grate/Utility Hazard?	N/A
	Obstruction Type			Storm Grate/Utility Type	
		N/A			N/A
			Yes	Surface Condition? (G/P)	Good

Remove & Replace Curb Ramp With Two New Directional Ramps or Equivalent.
