Access Compliance Report

Public Rights-of-Way

(Curb Ramps)

Intersection ID: 7913	Main Street: BROOKSHIRE_BV	Cross Street: N_CLOUDMAN_ST	Location: S
ADA ID: A952C9D460A6	Ramp Type: Para	Initial Pass/Fail: Fail	Overall Compliance: No
Codes/Mitigation Info/Possible Solution		Field Measurements/Component Compliance	
Severity Score: 26.25

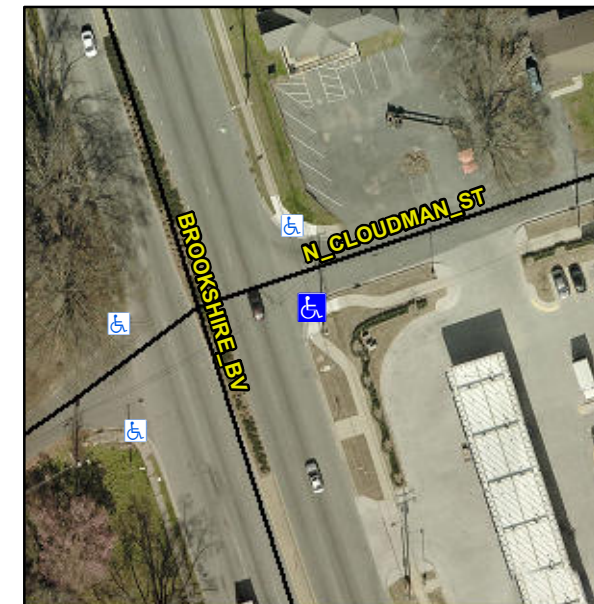
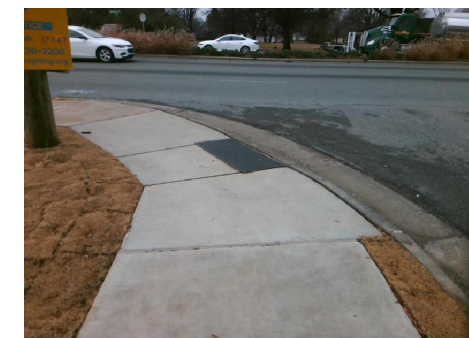
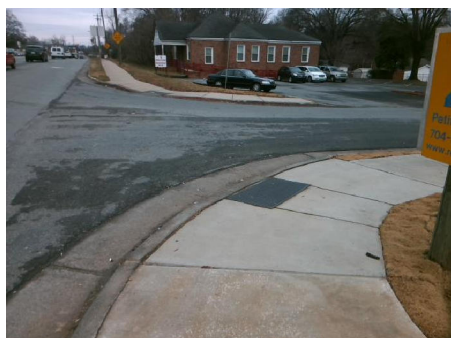
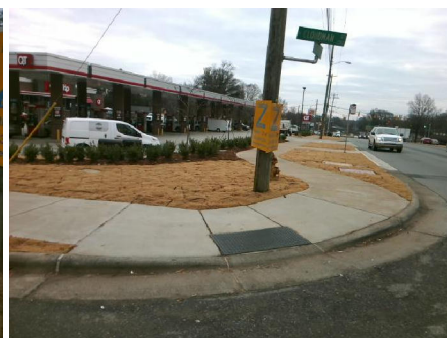
LT RP < 5%

R304.5.3, R304.3.2

Compliance	Description	Data	Compliance	Description	Data
N/A	Ramp Length LT (in)	46.0	N/A	Ramp Length RT (in)	47.0
Yes	Ramp Width LT (in)	71.0	Yes	Ramp Width RT (in)	71.0
Yes	Ramp Slope LT (%)	1.4	No	Ramp Slope RT (%)	12.0
No	Ramp XSlope LT (%)	3.2	Yes	Ramp XSlope RT (%)	1.4
N/A	Landing Length (in)	N/A	N/A	DWS Provided?	N/A
N/A	Landing Width (in)	N/A	N/A	DWS Contrast?	N/A
N/A	Landing Slope (%)	N/A	N/A	DWS Length (in)	N/A
N/A	Landing X Slope (%)	N/A	N/A	DWS Full Width?	N/A
N/A	Landing Curb? (Y/N)	N/A	N/A	DWS Offset (in)	N/A
N/A	Shared Landing?	N/A			
N/A	Gutter Ponding?	N/A	N/A	Gutter Slope (%)	N/A
N/A	Gutter Lip Ht (in)	N/A	N/A	Gutter X Slope (%)	N/A
N/A	Painted X Walk1?	No	N/A	Painted X Walk2?	N/A
	X Walk 1 Direction	To N		X Walk 2 Direction	N/A
N/A	X Walk 1 Width (in)	N/A	N/A	X Walk 2 Width (in)	N/A
	X Walk 1 Slope (%)	2.9		X Walk 2 Slope (%)	N/A
	X Walk 1 X Slope (%)	5.0		X Walk 2 X Slope (%)	N/A
N/A	Ramp inside XWalk1?	N/A	N/A	Ramp inside XWalk2?	N/A

Remove & Replace Entire Ramp.
