Access Compliance Report

Public Rights-of-Way

(Curb Ramps)

Intersection ID: N/A	Main Street: KIMMERLY_GLEN_LN	Cross Street: ENDOLWOOD_DR	Location: NW
ADA ID: A9596EB09B67	Ramp Type: Directional1	Initial Pass/Fail: Fail	Overall Compliance: No
		Severity Score: 25

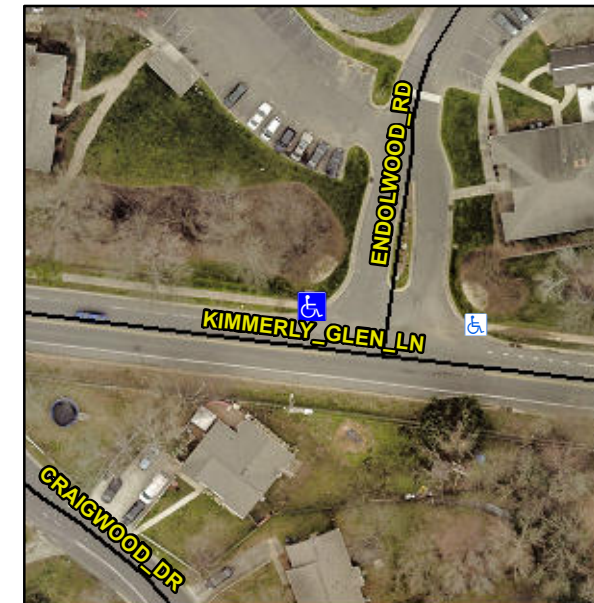
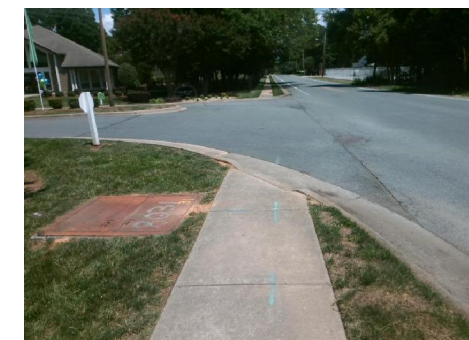
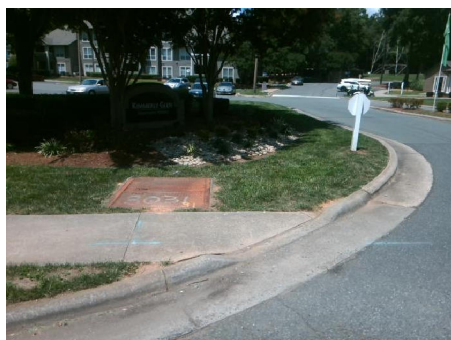
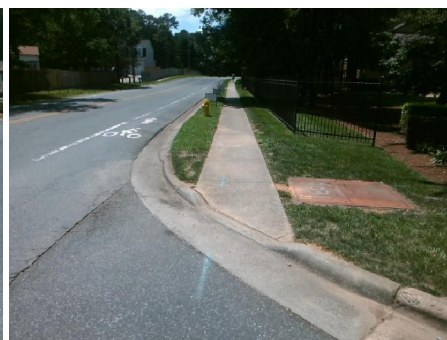
Compliance	Description	Data	Compliance	Description	Data
N/A	Ramp Length (in)	48.0	N/A	Grade Break?	N/A
Yes	Ramp Width (in)	48.0	N/A	Grade Break Slope (%)	0.0
No	Ramp Slope (%)	10.9	N/A	Grade Break XSlope (%)	0.0
No	Ramp XSlope (%)	6.4			
N/A	Flare Type LT	N/A	N/A	Flare Type RT	N/A
N/A	Flare Slope LT (%)	N/A	N/A	Flare Slope RT (%)	0.0
N/A	Flare Traversable LT?	N/A	N/A	Flare Traversable RT?	N/A
N/A	Landing Length (in)	0.0	N/A	DWS Provided?	N/A
N/A	Landing Width (in)	0.0	N/A	DWS Contrast?	N/A
N/A	Landing Slope (%)	0.0	N/A	DWS Length (in)	N/A
N/A	Landing X Slope (%)	0.0	N/A	DWS Full Width?	N/A
N/A	Landing Curb? (Y/N)	N/A	N/A	DWS Offset LT (in)	N/A
N/A	Shared Landing?	N/A	N/A	DWS Offset RT (in)	N/A
N/A	Gutter Ponding?	0.0	N/A	Gutter Slope (%)	N/A
N/A	Gutter Lip Ht (in)	0.0	N/A	Gutter X Slope (%)	N/A
N/A	Painted X Walk1?	No		Road Slope (%)	2.7
	X Walk 1 Direction	To E		Road X Slope (%)	2.2
	X Walk 1 Width (in)	N/A		Clear Space?	N/A

X Walk 1 Slope (%)	2.7	N/A	Clear Space to XWalk (in)	N/A
	X Walk 1 X Slope (%)	2.2	N/A	Storm Grate/Utility Hazard?	N/A
N/A	Ramp inside XWalk1?	N/A		Storm Grate/Utility Type	
N/A	Any Obstructions?	N/A			N/A
	Obstruction Type		Yes	Surface Condition? (G/P)	Good
			N/A	Curb Slope (%)	2.2

Remove & Replace Entire Ramp.

R304.2.2, R304.5.3
