Access Compliance Report

Public Rights-of-Way

(Curb Ramps)

Intersection ID: N/A	Main Street: CRESSWIND BV	Cross Street: TREESDALE LN	Location: W
ADA ID: A963B123F7E4	Ramp Type: BlendTrans1	Initial Pass/Fail: Fail	Overall Compliance: No
Severity Score: 1.25			
Codes/Mitigation Info/Possible Solution		Field Measurements/Component Compliance

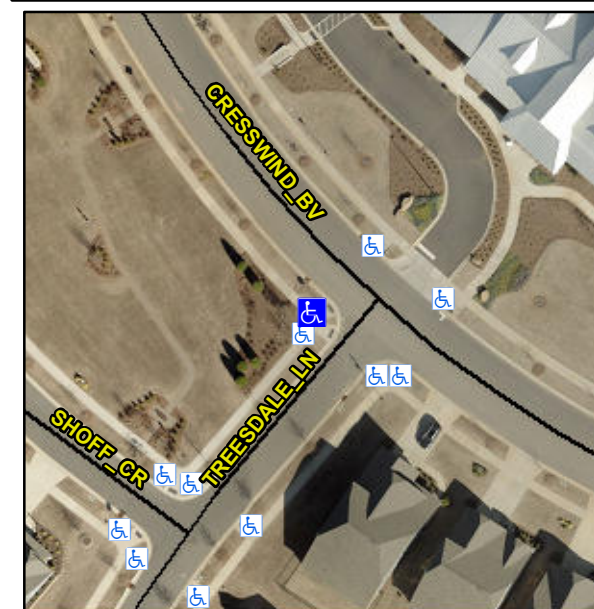
Not Found, R304.5.3

Compliance	Description	Data	Compliance	Description	Data
N/A	Ramp Length (in)	108.0	Yes	BlendTrans Slope (%)	4.5
Yes	Ramp Width (in)	60.0	No	BlendTrans XSlope (%)	3.5
N/A	Flare Type LT	N/A	N/A	Flare Type RT	N/A
N/A	Flare Slope LT (%)	N/A	N/A	Flare Slope RT (%)	N/A
N/A	Flare Traversable LT?	No	N/A	Flare Traversable RT?	No
N/A	Landing Length (in)	N/A	N/A	DWS Provided?	N/A
N/A	Landing Width (in)	N/A	N/A	DWS Contrast?	N/A
N/A	Landing Slope (%)	N/A	N/A	DWS Length (in)	N/A
N/A	Landing X Slope (%)	N/A	N/A	DWS Full Width?	N/A
N/A	Landing Curb? (Y/N)	N/A	N/A	DWS Offset (in)	N/A
N/A	Shared Landing?	N/A			
N/A	Gutter Ponding?	N/A	N/A	Gutter Slope (%)	N/A
N/A	Gutter Lip Ht (in)	0.5	N/A	Gutter X Slope (%)	N/A
N/A	Painted X Walk1?	No	N/A	Painted X Walk2?	N/A
	X Walk 1 Direction	To NE		X Walk 2 Direction	N/A
	X Walk 1 Width (in)	N/A		X Walk 2 Width (in)	N/A
	X Walk 1 Slope (%)	3.6		X Walk 2 Slope (%)	N/A
	X Walk 1 X Slope (%)	2.9		X Walk 2 X Slope (%)	N/A

N/A	Ramp inside XWalk1?	N/A	N/A	Ramp inside XWalk2?	N/A
	Road Slope (%)	2.9		Clear Space?	N/A
	Road X Slope (%)	3.6	N/A	Clear Space to XWalk (in)	N/A
N/A	Any Obstructions?	N/A	N/A	Storm Grate/Utility Hazard?	N/A
	Obstruction Type			Storm Grate/Utility Type	
		N/A			N/A
			Yes	Surface Condition? (G/P)	Good
			No	Curb Slope (%)	5.2

Remove & Replace Curb Ramp With Two New Directional Ramps or Equivalent.
