# Access Compliance Report

## Public Rights-of-Way

Intersection ID: 21216	Main Street: BROOKDALE_AV	Cross Street: WOODSTREAM_DR	Location: NE
ADA ID: A965B8D842E2	Ramp Type: PerpDiag	Initial Pass/Fail: Fail	Overall Compliance: No
Severity Score: 13.75			
Codes/Mitigation Info/Possible Solution		Field Measurements/Component Compliance

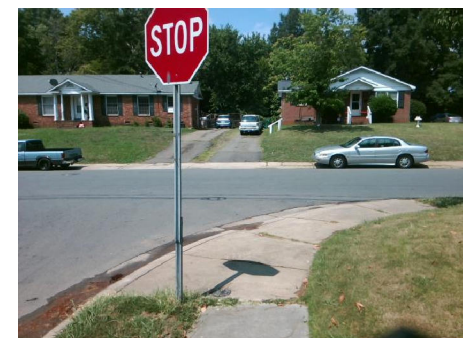
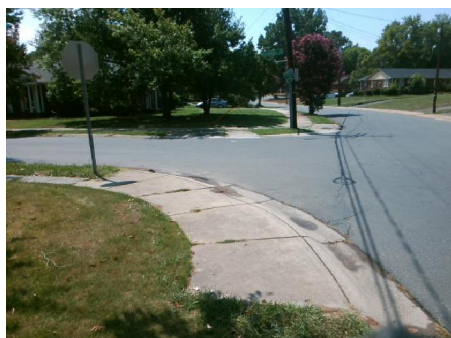
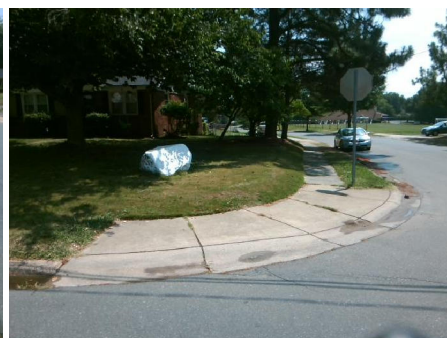
Compliance	Description	Data	Compliance	Description	Data
N/A	Ramp Length (in)	61.0	No	Ramp Slope (%)	10.1
Yes	Ramp Width (in)	50.0	No	Ramp XSlope (%)	3.9
N/A	Flare Type LT	N/A	N/A	Flare Type RT	N/A
N/A	Flare Slope LT (%)	N/A	N/A	Flare Slope RT (%)	N/A
N/A	Flare Traversable LT?	N/A	N/A	Flare Traversable RT?	N/A
N/A	Landing Length (in)	N/A	N/A	DWS Provided?	N/A
N/A	Landing Width (in)	N/A	N/A	DWS Contrast?	N/A
N/A	Landing Slope (%)	N/A	N/A	DWS Length (in)	N/A
N/A	Landing X Slope (%)	N/A	N/A	DWS Full Width?	N/A
N/A	Landing Curb? (Y/N)	N/A	N/A	DWS Offset (in)	N/A
N/A	Shared Landing?	N/A			
N/A	Gutter Ponding?	N/A	N/A	Gutter Slope (%)	N/A
N/A	Gutter Lip Ht (in)	N/A	N/A	Gutter X Slope (%)	N/A
N/A	Painted X Walk1?	No	N/A	Painted X Walk2?	No
	X Walk 1 Direction	To W		X Walk 2 Direction	To S
N/A	X Walk 1 Width (in)	N/A	N/A	X Walk 2 Width (in)	N/A
	X Walk 1 Slope (%)	5.7		X Walk 2 Slope (%)	0.0
	X Walk 1 X Slope (%)	0.8		X Walk 2 X Slope (%)	2.1

N/A	Ramp inside XWalk1?	N/A	N/A	Ramp inside XWalk2?	N/A
	Road Slope (%)	5.1	N/A	Clear Space?	N/A
	Road X Slope (%)	1.3	N/A	Clear Space to XWalk (in)	N/A
N/A	Any Obstructions?	N/A	N/A	Storm Grate/Utility Hazard?	N/A
	Obstruction Type			Storm Grate/Utility Type	
		N/A			N/A
		Yes		Surface Condition? (G/P)	Good

**Remove & Replace Curb Ramp With Two New Directional Ramps or Equivalent.**
