Access Compliance Report

Public Rights-of-Way

(Curb Ramps)

Intersection ID: 11265	Main Street: N_TRYON_ST	Cross Street: WADSWORTH_PL	Location: S
ADA ID: A97A143D4C4B	Ramp Type: Directional1	Initial Pass/Fail: Pass	Overall Compliance: No
Severity Score: 0			
Codes/Mitigation Info/Possible Solution		Field Measurements/Component Compliance

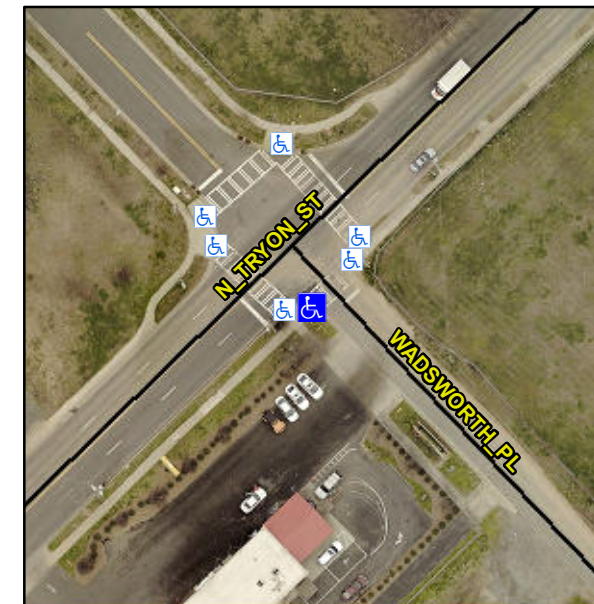
Not Found, R305.2, R302.7

Compliance	Description	Data	Compliance	Description	Data
N/A	Ramp Length (in)	110.0	Yes	Grade Break?	Yes
Yes	Ramp Width (in)	59.5	Yes	Grade Break Slope (%)	0.9
Yes	Ramp Slope (%)	1.3	Yes	Grade Break XSlope (%)	1.1
Yes	Ramp XSlope (%)	0.3			
Yes	Flare Type LT	N/A	Yes	Flare Type RT	N/A
N/A	Flare Slope LT (%)	N/A	N/A	Flare Slope RT (%)	N/A
N/A	Flare Traversable LT?	No	N/A	Flare Traversable RT?	No
Yes	Landing Length (in)	59.5	Yes	DWS Provided?	Yes
Yes	Landing Width (in)	59.5	Yes	DWS Contrast?	Yes
Yes	Landing Slope (%)	1.4	Yes	DWS Length (in)	24.0
Yes	Landing X Slope (%)	1.1	Yes	DWS Full Width?	Yes
N/A	Landing Curb? (Y/N)	No	Yes	DWS Offset LT (in)	16.0
N/A	Shared Landing?	Yes	No	DWS Offset RT (in)	4.0
No	Gutter Ponding?	Yes	Yes	Gutter Slope (%)	1.7
Yes	Gutter Lip Ht (in)	0.0	Yes	Gutter X Slope (%)	1.9
N/A	Painted X Walk1?	Yes		Road Slope (%)	0.6
	X Walk 1 Direction	To NE		Road X Slope (%)	3.8
	X Walk 1 Width (in)	118.5		Clear Space?	Yes

X Walk 1 Slope (%)	0.6	N/A	Clear Space to XWalk (in)	N/A
	X Walk 1 X Slope (%)	3.8	Yes	Storm Grate/Utility Hazard?	No
Yes	Ramp inside XWalk1?	Yes		Storm Grate/Utility Type	
Yes	Any Obstructions?	No			N/A
	Obstruction Type		Yes	Surface Condition? (G/P)	Good
			N/A	Curb Slope (%)	10.8

Possible Solutions:

Remove & Replace Entire Ramp.
