Access Compliance Report

Public Rights-of-Way

(Curb Ramps)

Intersection ID: 25122	Main Street: COPPER_RIDGE_TL	Cross Street: LAVENDER_TRACE_CT	Location: SW
ADA ID: A97FD2F6CE6E	Ramp Type: Perp	Initial Pass/Fail: Fail	Overall Compliance: No
Severity Score: 36.25			
Codes/Mitigation Info/Possible Solution		Field Measurements/Component Compliance

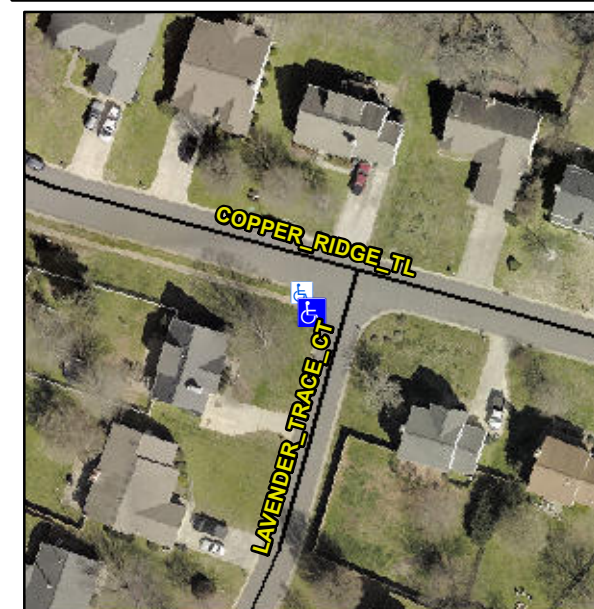
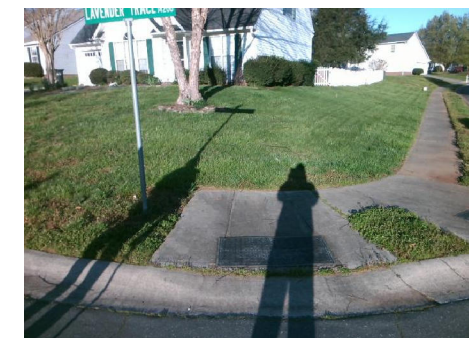
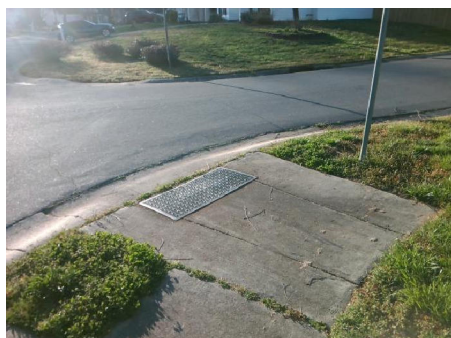
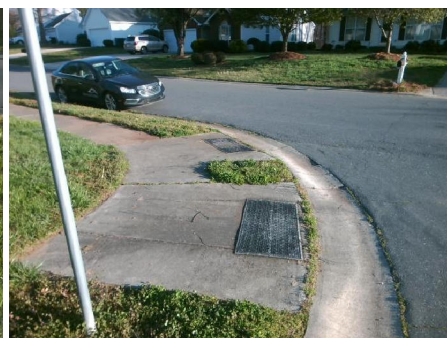
Compliance	Description	Data	Compliance	Description	Data
N/A	Ramp Length (in)	96.0	Yes	Ramp Slope (%)	6.6
No	Ramp Width (in)	31.0	No	Ramp XSlope (%)	3.8
N/A	Flare Type LT	N/A	N/A	Flare Type RT	N/A
N/A	Flare Slope LT (%)	N/A	N/A	Flare Slope RT (%)	N/A
N/A	Flare Traversable LT?	N/A	N/A	Flare Traversable RT?	N/A
N/A	Landing Length (in)	N/A	N/A	DWS Provided?	N/A
N/A	Landing Width (in)	N/A	N/A	DWS Contrast?	N/A
N/A	Landing Slope (%)	N/A	N/A	DWS Length (in)	N/A
N/A	Landing X Slope (%)	N/A	N/A	DWS Full Width?	N/A
N/A	Landing Curb? (Y/N)	N/A	N/A	DWS Offset (in)	N/A
N/A	Shared Landing?	N/A			
N/A	Gutter Ponding?	N/A	N/A	Gutter Slope (%)	N/A
N/A	Gutter Lip Ht (in)	N/A	N/A	Gutter X Slope (%)	N/A
N/A	Painted X Walk1?	No	N/A	Painted X Walk2?	N/A
	X Walk 1 Direction	To SE		X Walk 2 Direction	N/A
N/A	X Walk 1 Width (in)	N/A	N/A	X Walk 2 Width (in)	N/A
	X Walk 1 Slope (%)	0.7		X Walk 2 Slope (%)	N/A
	X Walk 1 X Slope (%)	1.6		X Walk 2 X Slope (%)	N/A

N/A	Ramp inside XWalk1?	N/A	N/A	Ramp inside XWalk2?	N/A
	Road Slope (%)	N/A	N/A	Clear Space?	N/A
	Road X Slope (%)	N/A	N/A	Clear Space to XWalk (in)	N/A
N/A	Any Obstructions?	N/A	N/A	Storm Grate/Utility Hazard?	N/A
	Obstruction Type			Storm Grate/Utility Type	
		N/A			N/A
			Yes	Surface Condition? (G/P)	Good

Possible Solutions:

Remove & Replace Entire Ramp.
