# Access Compliance Report

## Public Rights-of-Way

### (Curb Ramps)

Intersection ID: 17321	Main Street: QUEENS_RD_EAST	Cross Street: QUEENS_RD_WEST	Location: NW
ADA ID: A98A4BF91D47	Ramp Type: Perp	Initial Pass/Fail: Fail	Overall Compliance: No
Severity Score: 13.75			
Codes/Mitigation Info/Possible Solution		Field Measurements/Component Compliance

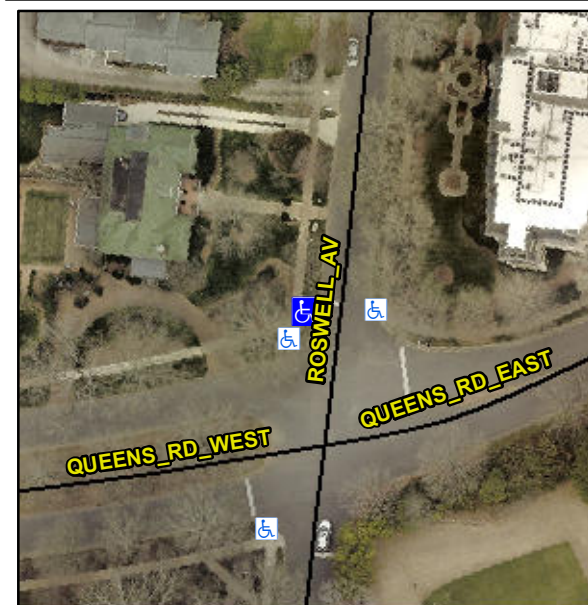
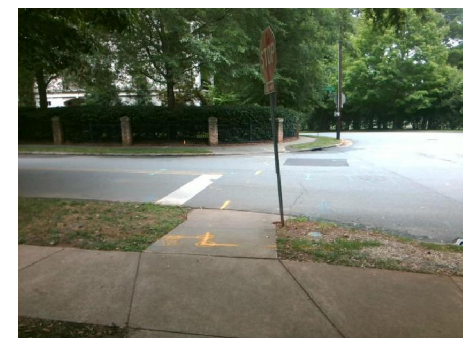
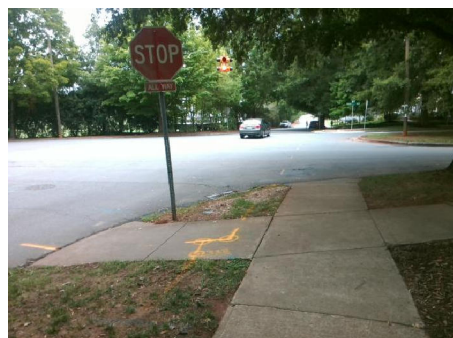
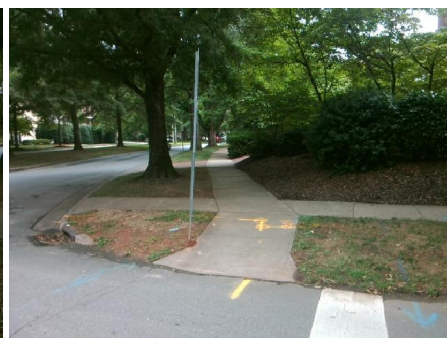
**Not Found, R304.2.2, R304.5.3**

Compliance	Description	Data	Compliance	Description	Data
N/A	Ramp Length (in)	105.0	No	Ramp Slope (%)	10.4
Yes	Ramp Width (in)	60.0	No	Ramp XSlope (%)	2.8
N/A	Flare Type LT	N/A	N/A	Flare Type RT	N/A
N/A	Flare Slope LT (%)	N/A	N/A	Flare Slope RT (%)	N/A
N/A	Flare Traversable LT?	N/A	N/A	Flare Traversable RT?	N/A
N/A	Landing Length (in)	N/A	N/A	DWS Provided?	N/A
N/A	Landing Width (in)	N/A	N/A	DWS Contrast?	N/A
N/A	Landing Slope (%)	N/A	N/A	DWS Length (in)	N/A
N/A	Landing X Slope (%)	N/A	N/A	DWS Full Width?	N/A
N/A	Landing Curb? (Y/N)	N/A	N/A	DWS Offset (in)	N/A
N/A	Shared Landing?	N/A			
N/A	Gutter Ponding?	N/A	N/A	Gutter Slope (%)	N/A
N/A	Gutter Lip Ht (in)	N/A	N/A	Gutter X Slope (%)	N/A
N/A	Painted X Walk1?	No	N/A	Painted X Walk2?	N/A
	X Walk 1 Direction	To E		X Walk 2 Direction	N/A
N/A	X Walk 1 Width (in)	N/A	N/A	X Walk 2 Width (in)	N/A
	X Walk 1 Slope (%)	4.2		X Walk 2 Slope (%)	N/A
	X Walk 1 X Slope (%)	0.5		X Walk 2 X Slope (%)	N/A

N/A	Ramp inside XWalk1?	N/A	N/A	Ramp inside XWalk2?	N/A
	Road Slope (%)	N/A	N/A	Clear Space?	N/A
	Road X Slope (%)	N/A	N/A	Clear Space to XWalk (in)	N/A
N/A	Any Obstructions?	N/A	N/A	Storm Grate/Utility Hazard?	N/A
	Obstruction Type			Storm Grate/Utility Type	
		N/A			N/A
			Yes	Surface Condition? (G/P)	Good

**Remove & Replace Entire Ramp.**
