Access Compliance Report

Public Rights-of-Way

(Curb Ramps)

Intersection ID: 18943	Main Street: GATE_POST_RD	Cross Street: RAMA_RD	Location: S
ADA ID: A99CFCB942FA	Ramp Type: ParaDiag	Initial Pass/Fail: Pass	Overall Compliance: No
Codes/Mitigation Info/Possible Solution		Field Measurements/Component Compliance	
Severity Score: 0.25

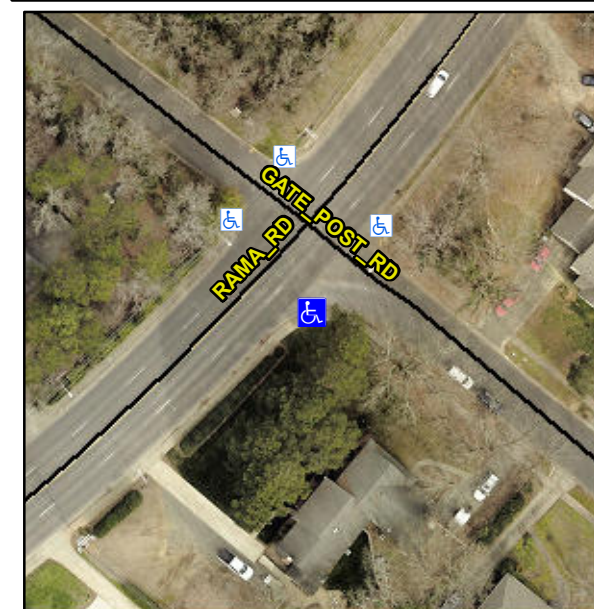
RT RP < 5%

R304.5.3, R304.2.1, R304.2.2-Perp, R304.3.2-Para, R305.2

Compliance	Description	Data	Compliance	Description	Data
N/A	Ramp Length LT (in)	69.0	N/A	Ramp Length RT (in)	68.0
Yes	Ramp Width LT (in)	60.0	Yes	Ramp Width RT (in)	60.0
Yes	Ramp Slope LT (%)	7.1	Yes	Ramp Slope RT (%)	0.9
No	Ramp XSlope LT (%)	3.1	No	Ramp XSlope RT (%)	3.9
Yes	Landing Length (in)	59.0	Yes	DWS Provided?	Yes
No	Landing Width (in)	45.0	Yes	DWS Contrast?	Yes
No	Landing Slope (%)	4.1	Yes	DWS Length (in)	24.0
No	Landing X Slope (%)	2.7	Yes	DWS Full Width?	Yes
N/A	Landing Curb? (Y/N)	No	No	DWS Offset (in)	5.0
N/A	Shared Landing?	No			
Yes	Gutter Ponding?	No	Yes	Gutter Slope (%)	0.7
Yes	Gutter Lip Ht (in)	0.0	No	Gutter X Slope (%)	3.4
N/A	Painted X Walk1?	No	N/A	Painted X Walk2?	No
	X Walk 1 Direction	To NE		X Walk 2 Direction	To NW
N/A	X Walk 1 Width (in)	N/A	N/A	X Walk 2 Width (in)	N/A
	X Walk 1 Slope (%)	3.7		X Walk 2 Slope (%)	2.1
	X Walk 1 X Slope (%)	1.1		X Walk 2 X Slope (%)	6.1
N/A	Ramp inside XWalk1?	N/A	N/A	Ramp inside XWalk2?	N/A

Road Slope (%)	2.9	N/A	Clear Space?	Yes
	Road X Slope (%)	3.0	N/A	Clear Space to XWalk (in)	N/A
Yes	Any Obstructions?	No	Yes	Storm Grate/Utility Hazard?	No
	Obstruction Type			Storm Grate/Utility Type	
		N/A			N/A
			Yes	Surface Condition? (G/P)	Good
			N/A	Curb Slope (%)	9.6

Possible Solutions:

Remove & Replace Curb Ramp With Two New Directional Ramps or Equivalent. Remove & Replace Gutter.
