# Access Compliance Report

## Public Rights-of-Way

### (Curb Ramps)

Intersection ID: N/A	Main Street: SPRINGWOOD_ESTATE_DR	Cross Street: BELVEDERE_CASTLE_DR	Location: SW
ADA ID: A9A9BD68818E	Ramp Type: Perp	Initial Pass/Fail: Pass	Overall Compliance: No
		Severity Score: 0

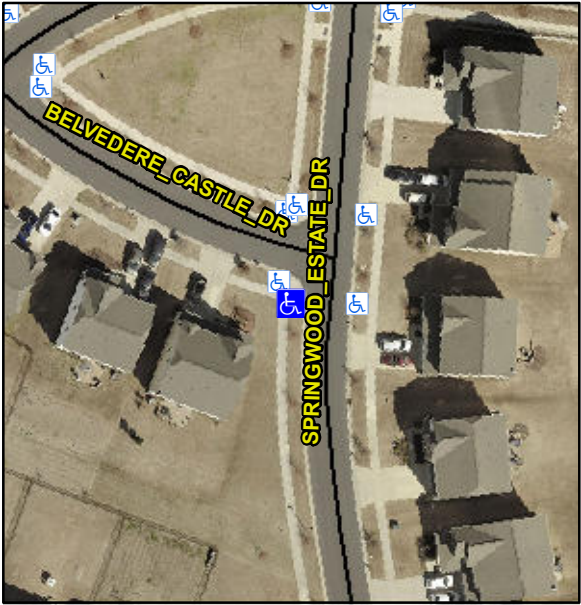
Possible Solutions:		<b>Compliance</b>	<b>Description</b>	<b>Data</b>
	Remove & Replace Entire Ramp.		<b>Compliance</b>	<b>Description</b>	<b>Data</b>
			N/A	Ramp Length (in)	95.0
			Yes	Ramp Width (in)	48.0
			N/A	Flare Type LT	Sloped
			N/A	Flare Slope LT (%)	5.6
			N/A	Flare Traversable LT?	Yes
			Yes	Landing Length (in)	59.5
			Yes	Landing Width (in)	48.0
			Yes	Landing Slope (%)	1.1
<p>Surveyor Notes:</p> <p>N/A</p> <p>PROW/ADA:</p> <p>Not Found, R305.2</p>			Yes	Landing X Slope (%)	1.4
			N/A	Landing Curb? (Y/N)	No
			N/A	Shared Landing?	No
			Yes	Gutter Ponding?	No
			Yes	Gutter Lip Ht (in)	0.0
			N/A	Painted X Walk1?	No
				X Walk 1 Direction	To E
			N/A	X Walk 1 Width (in)	N/A
				X Walk 1 Slope (%)	6.9
				X Walk 1 X Slope (%)	0.9
<p>Street 1 Name</p> <p>Stop Condition-Street 2</p> <p>Street 2 Name</p> <p>Stop Condition-Street 1</p>			N/A	Ramp inside XWalk1?	N/A

Road Slope (%)	N/A
				Road X Slope (%)	N/A
			Yes	Any Obstructions?	No
				Obstruction Type	
			N/A		
			Yes	Surface Condition? (G/P)	Good
Total Cost:		\$ 1850.00
