Access Compliance Report

Public Rights-of-Way

(Curb Ramps)

| Intersection ID: 4413 | Main Street: CHASTAIN_PARC_DR | Cross Street: WATTS DALE_AV | Location: SE |

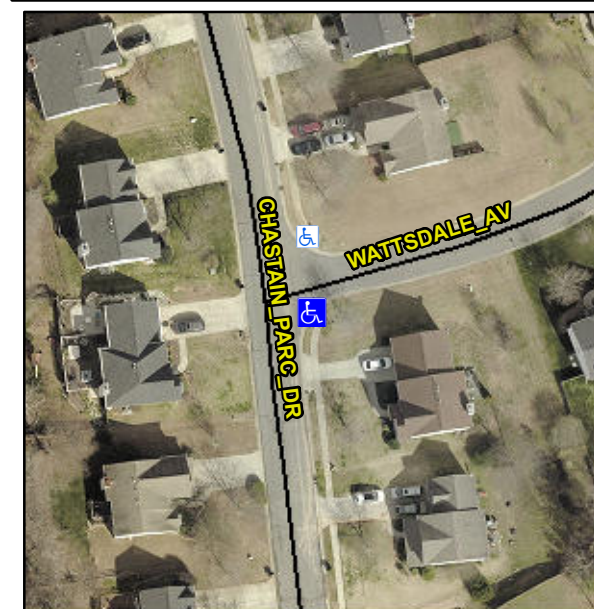
| ADA ID: A9B73326E20A | Ramp Type: BlendTrans1 | Initial Pass/Fail: Fail | Overall Compliance: No |

Not Found, R304.5.1, R304.5.3

| Compliance | Description | Data | Compliance | Description | Data |
|---|---|---|---|---|---|
| No | Ramp Width (in) | 46.0 | No | BlendTrans XSlope (%) | 8.6 |

Remove & Replace Curb Ramp With Two New Directional Ramps or Equivalent.

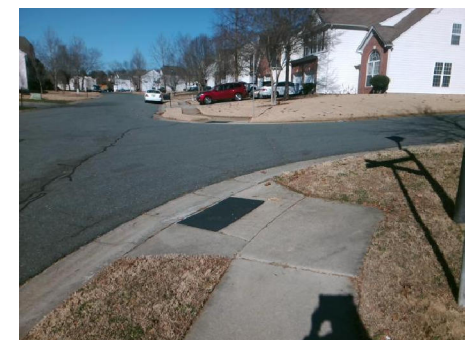
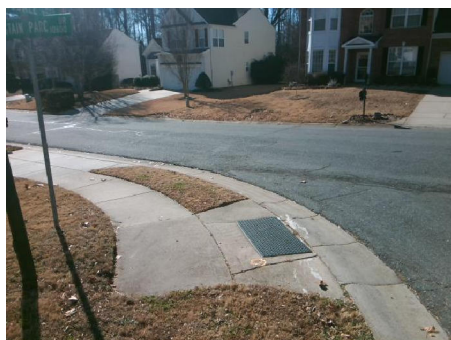
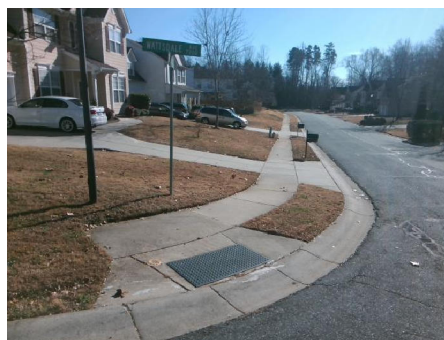
| Compliance | Description | Data | Compliance | Description | Data |
|---|---|---|---|---|---|
| | | | No | Curb Slope (%) | 21.6 |
