Access Compliance Report

Public Rights-of-Way

(Curb Ramps)

Intersection ID: 16778	Main Street: BERTONLEY_AV	Cross Street: RICHLAND_DR	Location: SW
ADA ID: A9B959E373DC	Ramp Type: PerpDiag	Initial Pass/Fail: Fail	Overall Compliance: No
Codes/Mitigation Info/Possible Solution		Field Measurements/Component Compliance

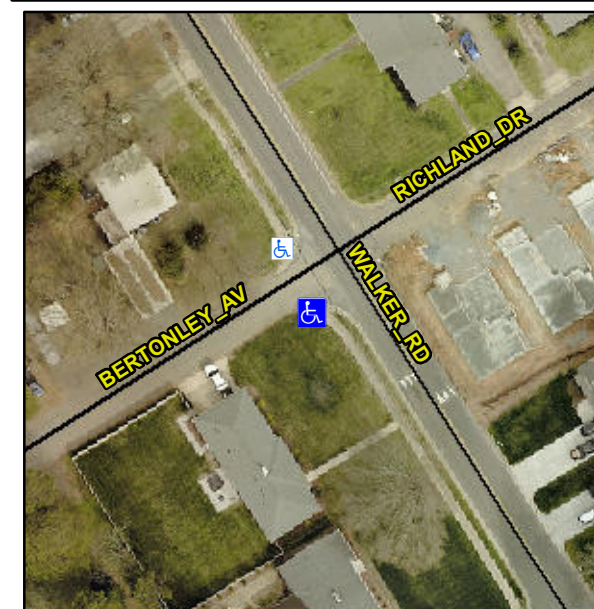
Not Found, R304.5.1, R304.2.2

Compliance	Description	Data	Compliance	Description	Data
N/A	Ramp Length (in)	28.0	No	Ramp Slope (%)	9.9
No	Ramp Width (in)	44.0	Yes	Ramp XSlope (%)	1.6
N/A	Flare Type LT	N/A	N/A	Flare Type RT	N/A
N/A	Flare Slope LT (%)	N/A	N/A	Flare Slope RT (%)	N/A
N/A	Flare Traversable LT?	N/A	N/A	Flare Traversable RT?	N/A
N/A	Landing Length (in)	N/A	N/A	DWS Provided?	N/A
N/A	Landing Width (in)	N/A	N/A	DWS Contrast?	N/A
N/A	Landing Slope (%)	N/A	N/A	DWS Length (in)	N/A
N/A	Landing X Slope (%)	N/A	N/A	DWS Full Width?	N/A
N/A	Landing Curb? (Y/N)	N/A	N/A	DWS Offset (in)	N/A
N/A	Shared Landing?	N/A			
N/A	Gutter Ponding?	N/A	N/A	Gutter Slope (%)	N/A
N/A	Gutter Lip Ht (in)	N/A	N/A	Gutter X Slope (%)	N/A
N/A	Painted X Walk1?	No	N/A	Painted X Walk2?	No
	X Walk 1 Direction	To E		X Walk 2 Direction	To NW
N/A	X Walk 1 Width (in)	N/A	N/A	X Walk 2 Width (in)	N/A
	X Walk 1 Slope (%)	2.6		X Walk 2 Slope (%)	2.8
	X Walk 1 X Slope (%)	3.0		X Walk 2 X Slope (%)	0.1

N/A	Ramp inside XWalk1?	N/A	N/A	Ramp inside XWalk2?	N/A
	Road Slope (%)	0.7	N/A	Clear Space?	N/A
	Road X Slope (%)	1.5	N/A	Clear Space to XWalk (in)	N/A
N/A	Any Obstructions?	N/A	N/A	Storm Grate/Utility Hazard?	N/A
	Obstruction Type			Storm Grate/Utility Type	
		N/A			N/A
			Yes	Surface Condition? (G/P)	Good

Remove & Replace Curb Ramp With Two New Directional Ramps or Equivalent.
