# Access Compliance Report

## Public Rights-of-Way (Curb Ramps)

Intersection ID: 49655	Main Street: GREENWAY_CRESCENT_LN	Cross Street: SEIGLE_POINT_DR	Location:	E
ADA ID: A9CDAFE0CF60	Ramp Type: Directional1	Initial Pass/Fail: Fail	Overall Compliance: No	Severity Score: 25
Codes/Mitigation Info/Possible Solution		Field Measurements/Component Compliance

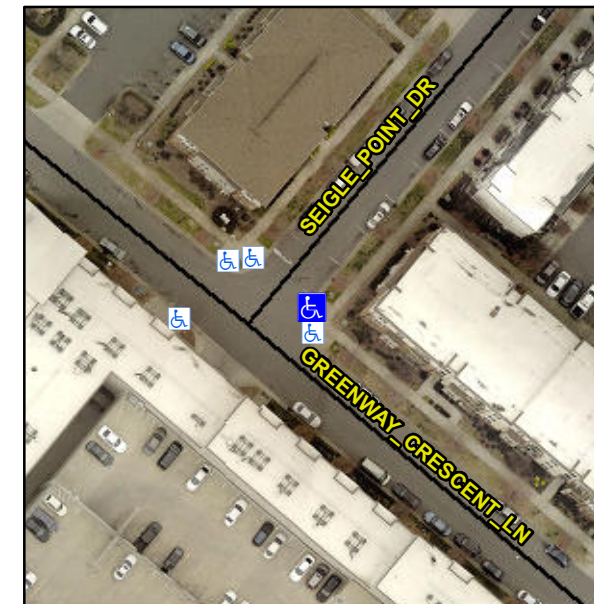
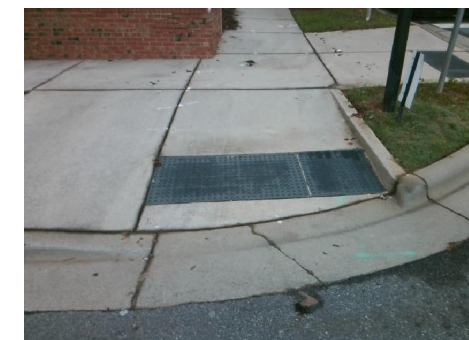
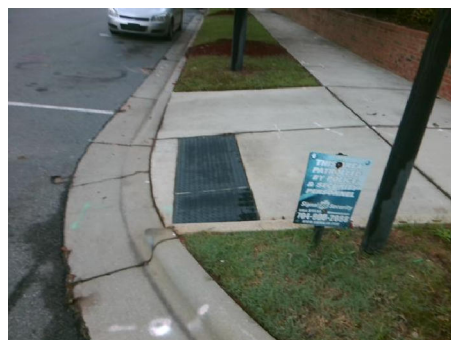
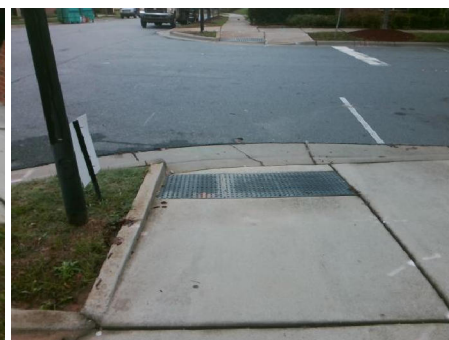
Compliance	Description	Data	Compliance	Description	Data
N/A	Ramp Length (in)	83.0	N/A	Grade Break?	N/A
Yes	Ramp Width (in)	71.5	N/A	Grade Break Slope (%)	0.0
No	Ramp Slope (%)	12.8	N/A	Grade Break XSlope (%)	0.0
Yes	Ramp XSlope (%)	1.2			
N/A	Flare Type LT	N/A	N/A	Flare Type RT	N/A
N/A	Flare Slope LT (%)	N/A	N/A	Flare Slope RT (%)	0.0
N/A	Flare Traversable LT?	N/A	N/A	Flare Traversable RT?	N/A
N/A	Landing Length (in)	0.0	N/A	DWS Provided?	N/A
N/A	Landing Width (in)	0.0	N/A	DWS Contrast?	N/A
N/A	Landing Slope (%)	0.0	N/A	DWS Length (in)	N/A
N/A	Landing X Slope (%)	0.0	N/A	DWS Full Width?	N/A
N/A	Landing Curb? (Y/N)	N/A	N/A	DWS Offset LT (in)	N/A
N/A	Shared Landing?	N/A	N/A	DWS Offset RT (in)	N/A
N/A	Gutter Ponding?	0.0	N/A	Gutter Slope (%)	N/A
N/A	Gutter Lip Ht (in)	0.0	N/A	Gutter X Slope (%)	N/A
N/A	Painted X Walk1?	No		Road Slope (%)	1.4
	X Walk 1 Direction	To NW		Road X Slope (%)	3.7
	X Walk 1 Width (in)	N/A		Clear Space?	N/A

X Walk 1 Slope (%)	1.4	N/A	Clear Space to XWalk (in)	N/A
	X Walk 1 X Slope (%)	3.7	N/A	Storm Grate/Utility Hazard?	N/A
N/A	Ramp inside XWalk1?	N/A		Storm Grate/Utility Type	
N/A	Any Obstructions?	N/A			N/A
	Obstruction Type		Yes	Surface Condition? (G/P)	Good
			N/A	Curb Slope (%)	2.3

Possible Solutions:

**Remove & Replace Entire Ramp.**

**R304.2.2**
