Intersection ID: 44723	Main Street: PROSPERITY_CHURCH_RD	Cross Street: JOHNSTON_OEHLE_R	Location:	NW
ADA ID: A9D173A54BDB	Ramp Type: IslandPerp	Initial Pass/Fail: Fail	Overall Compliance: No	Severity Score: 48.75

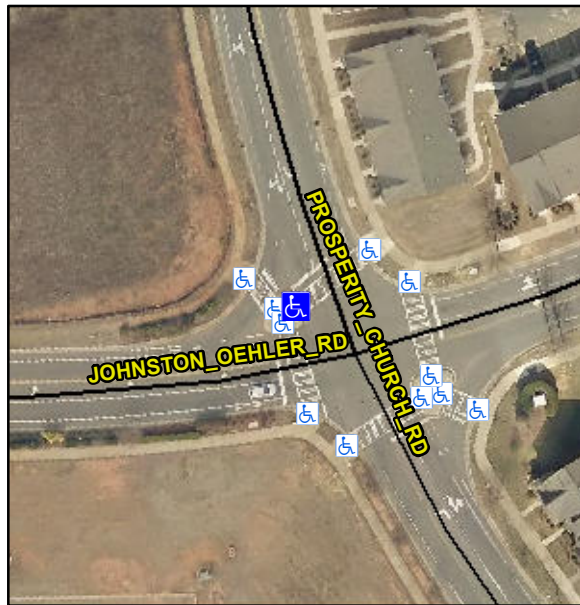
R304.5.1, R304.2.2

Compliance	Description	Data	Compliance	Description	Data
N/A	Ramp Length (in)	52.0	No	Ramp Slope (%)	10.7
No	Ramp Width (in)	31.0	Yes	Ramp XSlope (%)	3.0
N/A	Flare Type LT	N/A	N/A	Flare Type RT	N/A
N/A	Flare Slope LT (%)	N/A	N/A	Flare Slope RT (%)	N/A
N/A	Flare Traversable LT?	N/A	N/A	Flare Traversable RT?	N/A
N/A	Landing Length (in)	N/A	N/A	DWS Provided?	N/A
N/A	Landing Width (in)	N/A	N/A	DWS Contrast?	N/A
N/A	Landing Slope (%)	N/A	N/A	DWS Length (in)	N/A
N/A	Landing X Slope (%)	N/A	N/A	DWS Full Width?	N/A
N/A	Landing Curb? (Y/N)	N/A	N/A	DWS Offset (in)	N/A
N/A	Shared Landing?	N/A			
N/A	Gutter Ponding?	N/A	N/A	Gutter Slope (%)	N/A
N/A	Gutter Lip Ht (in)	N/A	N/A	Gutter X Slope (%)	N/A
N/A	Painted X Walk1?	Yes	N/A	Painted X Walk2?	N/A
	X Walk 1 Direction	To NE		X Walk 2 Direction	N/A
N/A	X Walk 1 Width (in)	105.0	N/A	X Walk 2 Width (in)	N/A
	X Walk 1 Slope (%)	0.5		X Walk 2 Slope (%)	N/A
	X Walk 1 X Slope (%)	3.3		X Walk 2 X Slope (%)	N/A

N/A	Ramp inside XWalk1?	Yes	N/A	Ramp inside XWalk2?	N/A
	Road Slope (%)	N/A	N/A	Clear Space?	N/A
	Road X Slope (%)	N/A	N/A	Clear Space to XWalk (in)	N/A
N/A	Any Obstructions?	N/A	N/A	Storm Grate/Utility Hazard?	N/A
	Obstruction Type			Storm Grate/Utility Type	
		N/A			N/A
			Yes	Surface Condition? (G/P)	Good

Remove & Replace Entire Ramp.

Total Cost: \$ 3400.00
