Access Compliance Report

Public Rights-of-Way

(Curb Ramps)

Intersection ID: 6465	Main Street: PEACHTREE_RD	Cross Street: OAKDALE_RD	Location: NW
ADA ID: A9E4E96C234F	Ramp Type: Perp	Initial Pass/Fail: Fail	Overall Compliance: No
Codes/Mitigation Info/Possible Solution		Field Measurements/Component Compliance	
Severity Score: 8.75

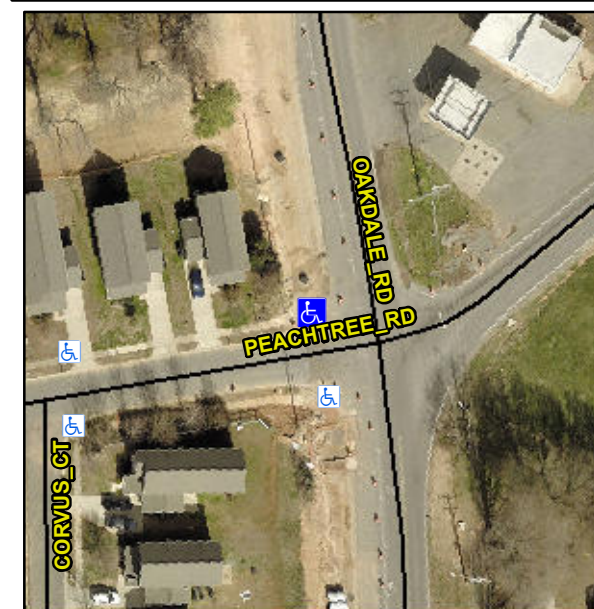
Not Found, R304.5.1

Compliance	Description	Data	Compliance	Description	Data
N/A	Ramp Length (in)	46.0	Yes	Ramp Slope (%)	6.0
No	Ramp Width (in)	41.0	Yes	Ramp XSlope (%)	1.0
N/A	Flare Type LT	N/A	N/A	Flare Type RT	N/A
N/A	Flare Slope LT (%)	N/A	N/A	Flare Slope RT (%)	N/A
N/A	Flare Traversable LT?	N/A	N/A	Flare Traversable RT?	N/A
N/A	Landing Length (in)	N/A	N/A	DWS Provided?	N/A
N/A	Landing Width (in)	N/A	N/A	DWS Contrast?	N/A
N/A	Landing Slope (%)	N/A	N/A	DWS Length (in)	N/A
N/A	Landing X Slope (%)	N/A	N/A	DWS Full Width?	N/A
N/A	Landing Curb? (Y/N)	N/A	N/A	DWS Offset (in)	N/A
N/A	Shared Landing?	N/A			
N/A	Gutter Ponding?	N/A	N/A	Gutter Slope (%)	N/A
N/A	Gutter Lip Ht (in)	N/A	N/A	Gutter X Slope (%)	N/A
N/A	Painted X Walk1?	No	N/A	Painted X Walk2?	N/A
	X Walk 1 Direction	To S		X Walk 2 Direction	N/A
N/A	X Walk 1 Width (in)	N/A	N/A	X Walk 2 Width (in)	N/A
	X Walk 1 Slope (%)	2.2		X Walk 2 Slope (%)	N/A
	X Walk 1 X Slope (%)	0.5		X Walk 2 X Slope (%)	N/A

N/A	Ramp inside XWalk1?	N/A	N/A	Ramp inside XWalk2?	N/A
	Road Slope (%)	N/A	N/A	Clear Space?	N/A
	Road X Slope (%)	N/A	N/A	Clear Space to XWalk (in)	N/A
N/A	Any Obstructions?	N/A	N/A	Storm Grate/Utility Hazard?	N/A
	Obstruction Type			Storm Grate/Utility Type	
		N/A			N/A
			Yes	Surface Condition? (G/P)	Good

Remove & Replace Entire Ramp.
