Access Compliance Report

Public Rights-of-Way

(Curb Ramps)

Intersection ID: 3270	Main Street: BATTLE_CREEK_CT	Cross Street: OLD_TIMBER_RD	Location: W
ADA ID: A9E5EA76ED22	Ramp Type: Perp	Initial Pass/Fail: Fail	Overall Compliance: No
Severity Score: 10			
Codes/Mitigation Info/Possible Solution		Field Measurements/Component Compliance

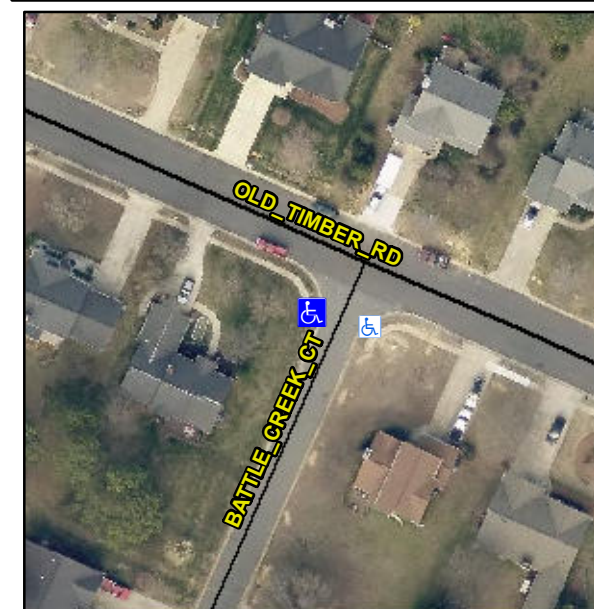
Compliance	Description	Data	Compliance	Description	Data
N/A	Ramp Length (in)	56.0	Yes	Ramp Slope (%)	6.8
No	Ramp Width (in)	40.0	No	Ramp XSlope (%)	2.6
N/A	Flare Type LT	N/A	N/A	Flare Type RT	N/A
N/A	Flare Slope LT (%)	N/A	N/A	Flare Slope RT (%)	N/A
N/A	Flare Traversable LT?	N/A	N/A	Flare Traversable RT?	N/A
N/A	Landing Length (in)	N/A	N/A	DWS Provided?	N/A
N/A	Landing Width (in)	N/A	N/A	DWS Contrast?	N/A
N/A	Landing Slope (%)	N/A	N/A	DWS Length (in)	N/A
N/A	Landing X Slope (%)	N/A	N/A	DWS Full Width?	N/A
N/A	Landing Curb? (Y/N)	N/A	N/A	DWS Offset (in)	N/A
N/A	Shared Landing?	N/A			
N/A	Gutter Ponding?	N/A	N/A	Gutter Slope (%)	N/A
N/A	Gutter Lip Ht (in)	N/A	N/A	Gutter X Slope (%)	N/A
N/A	Painted X Walk1?	No	N/A	Painted X Walk2?	N/A
	X Walk 1 Direction	To SE		X Walk 2 Direction	N/A
N/A	X Walk 1 Width (in)	N/A	N/A	X Walk 2 Width (in)	N/A
	X Walk 1 Slope (%)	4.5		X Walk 2 Slope (%)	N/A
	X Walk 1 X Slope (%)	3.3		X Walk 2 X Slope (%)	N/A

N/A	Ramp inside XWalk1?	N/A	N/A	Ramp inside XWalk2?	N/A
	Road Slope (%)	N/A	N/A	Clear Space?	N/A
	Road X Slope (%)	N/A	N/A	Clear Space to XWalk (in)	N/A
N/A	Any Obstructions?	N/A	N/A	Storm Grate/Utility Hazard?	N/A
	Obstruction Type			Storm Grate/Utility Type	
		N/A			N/A
		Yes		Surface Condition? (G/P)	Good

Possible Solutions:

Remove & Replace Entire Ramp.

PROW/ADA:

R304.5.1, R304.5.3

Total Cost: \$ 1850.00
