Access Compliance Report

Public Rights-of-Way

(Curb Ramps)

Intersection ID: 47300	Main Street: LELA_AV	Cross Street: HURSTON_CR	Location: E
ADA ID: A9E6C7D5C46B	Ramp Type: PerpDiag	Initial Pass/Fail: Fail	Overall Compliance: No
		Severity Score: 10

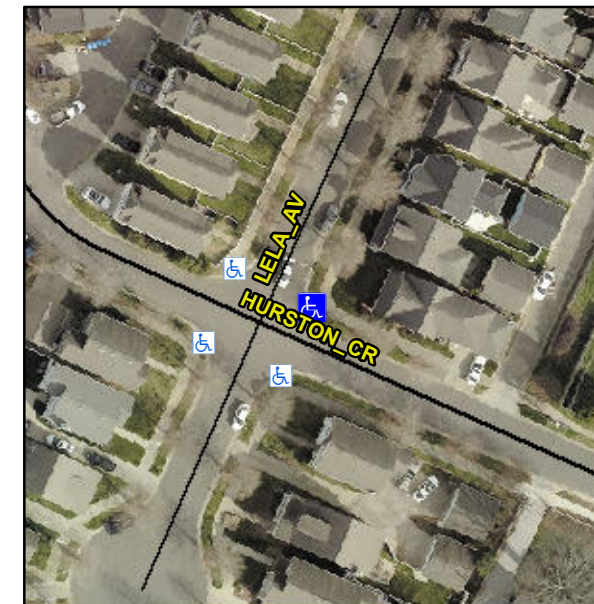
Not Found, R304.5.1, R304.5.3

Compliance	Description	Data	Compliance	Description	Data
N/A	Ramp Length (in)	72.0	Yes	Ramp Slope (%)	6.3
No	Ramp Width (in)	40.5	No	Ramp XSlope (%)	4.0
N/A	Flare Type LT	N/A	N/A	Flare Type RT	N/A
N/A	Flare Slope LT (%)	N/A	N/A	Flare Slope RT (%)	N/A
N/A	Flare Traversable LT?	N/A	N/A	Flare Traversable RT?	N/A
N/A	Landing Length (in)	N/A	N/A	DWS Provided?	N/A
N/A	Landing Width (in)	N/A	N/A	DWS Contrast?	N/A
N/A	Landing Slope (%)	N/A	N/A	DWS Length (in)	N/A
N/A	Landing X Slope (%)	N/A	N/A	DWS Full Width?	N/A
N/A	Landing Curb? (Y/N)	N/A	N/A	DWS Offset (in)	N/A
N/A	Shared Landing?	N/A			
N/A	Gutter Ponding?	N/A	N/A	Gutter Slope (%)	N/A
N/A	Gutter Lip Ht (in)	N/A	N/A	Gutter X Slope (%)	N/A
N/A	Painted X Walk1?	No	N/A	Painted X Walk2?	No
	X Walk 1 Direction	To NW		X Walk 2 Direction	To SW
N/A	X Walk 1 Width (in)	N/A	N/A	X Walk 2 Width (in)	N/A
	X Walk 1 Slope (%)	1.4		X Walk 2 Slope (%)	0.2
	X Walk 1 X Slope (%)	0.5		X Walk 2 X Slope (%)	3.2

N/A	Ramp inside XWalk1?	N/A	N/A	Ramp inside XWalk2?	N/A
	Road Slope (%)	3.5	N/A	Clear Space?	N/A
	Road X Slope (%)	2.1	N/A	Clear Space to XWalk (in)	N/A
N/A	Any Obstructions?	N/A	N/A	Storm Grate/Utility Hazard?	N/A
	Obstruction Type			Storm Grate/Utility Type	
		N/A			N/A
			Yes	Surface Condition? (G/P)	Good

Remove & Replace Curb Ramp With Two New Directional Ramps or Equivalent.

Total Cost: \$ 3200.00
