# Access Compliance Report

## Public Rights-of-Way (Curb Ramps)

Intersection ID: N/A	Main Street: INDEPENDENCE_RD	Cross Street: N/A	Location: SW
ADA ID: A9E6F32D1C7C	Ramp Type: Directional1	Initial Pass/Fail: Fail	Overall Compliance: No
		Severity Score: 21.25

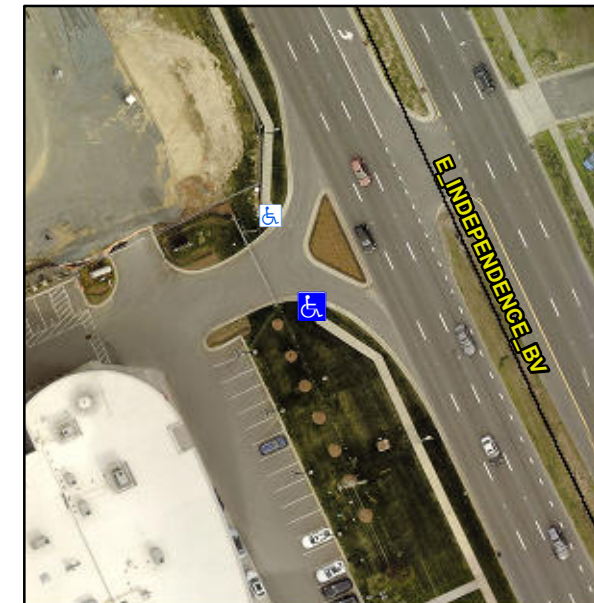
**R304.5.1, R304.2.2**

Compliance	Description	Data	Compliance	Description	Data
N/A	Ramp Length (in)	91.0	N/A	Grade Break?	N/A
No	Ramp Width (in)	47.5	N/A	Grade Break Slope (%)	0.0
No	Ramp Slope (%)	8.8	N/A	Grade Break XSlope (%)	0.0
Yes	Ramp XSlope (%)	1.9			
N/A	Flare Type LT	N/A	N/A	Flare Type RT	N/A
N/A	Flare Slope LT (%)	N/A	N/A	Flare Slope RT (%)	0.0
N/A	Flare Traversable LT?	N/A	N/A	Flare Traversable RT?	N/A
N/A	Landing Length (in)	0.0	N/A	DWS Provided?	N/A
N/A	Landing Width (in)	0.0	N/A	DWS Contrast?	N/A
N/A	Landing Slope (%)	0.0	N/A	DWS Length (in)	N/A
N/A	Landing X Slope (%)	0.0	N/A	DWS Full Width?	N/A
N/A	Landing Curb? (Y/N)	N/A	N/A	DWS Offset LT (in)	N/A
N/A	Shared Landing?	N/A	N/A	DWS Offset RT (in)	N/A
N/A	Gutter Ponding?	0.0	N/A	Gutter Slope (%)	N/A
N/A	Gutter Lip Ht (in)	0.0	N/A	Gutter X Slope (%)	N/A
N/A	Painted X Walk1?	No		Road Slope (%)	4.3
	X Walk 1 Direction	To N		Road X Slope (%)	5.3
	X Walk 1 Width (in)	N/A		Clear Space?	N/A

X Walk 1 Slope (%)	4.3	N/A	Clear Space to XWalk (in)	N/A
	X Walk 1 X Slope (%)	5.3	N/A	Storm Grate/Utility Hazard?	N/A
N/A	Ramp inside XWalk1?	N/A		Storm Grate/Utility Type	
N/A	Any Obstructions?	N/A			N/A
	Obstruction Type		Yes	Surface Condition? (G/P)	Good
			N/A	Curb Slope (%)	10.2

**Remove & Replace Entire Ramp.**
