# Access Compliance Report

## Public Rights-of-Way

### (Curb Ramps)

Intersection ID: 32023	Main Street: CORNWALLIS_CAMP_DR	Cross Street: WESSYNTON_DR	Location: SE
ADA ID: A9E7811674C8	Ramp Type: BlendTrans2	Initial Pass/Fail: Fail	Overall Compliance: No
Severity Score: 8.75			
Codes/Mitigation Info/Possible Solution		Field Measurements/Component Compliance

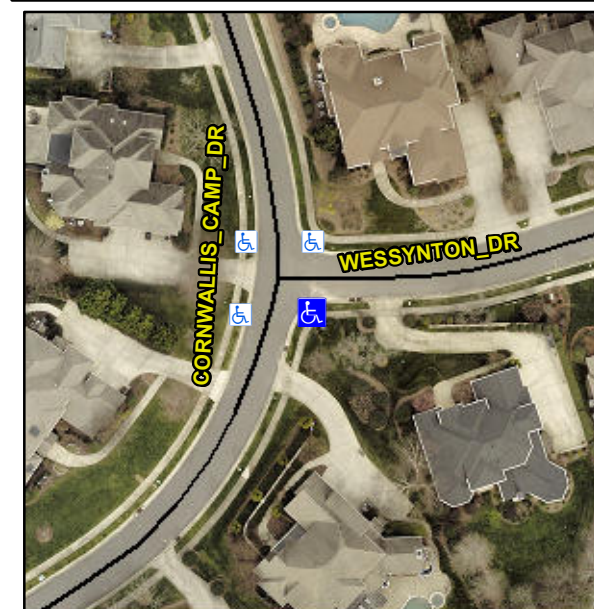
Compliance	Description	Data	Compliance	Description	Data
N/A	Ramp Length (in)	50.0	Yes	BlendTrans Slope (%)	3.3
No	Ramp Width (in)	40.0	Yes	BlendTrans XSlope (%)	1.2
N/A	Flare Type LT	N/A	N/A	Flare Type RT	N/A
N/A	Flare Slope LT (%)	N/A	N/A	Flare Slope RT (%)	N/A
N/A	Flare Traversable LT?	N/A	N/A	Flare Traversable RT?	N/A
N/A	Landing Length (in)	N/A	N/A	DWS Provided?	N/A
N/A	Landing Width (in)	N/A	N/A	DWS Contrast?	N/A
N/A	Landing Slope (%)	N/A	N/A	DWS Length (in)	N/A
N/A	Landing X Slope (%)	N/A	N/A	DWS Full Width?	N/A
N/A	Landing Curb? (Y/N)	N/A	N/A	DWS Offset (in)	N/A
N/A	Shared Landing?	N/A			
N/A	Gutter Ponding?	Yes	N/A	Gutter Slope (%)	N/A
N/A	Gutter Lip Ht (in)	N/A	N/A	Gutter X Slope (%)	N/A
N/A	Painted X Walk1?	No	N/A	Painted X Walk2?	No
	X Walk 1 Direction	To N		X Walk 2 Direction	To W
	X Walk 1 Width (in)	N/A		X Walk 2 Width (in)	N/A
	X Walk 1 Slope (%)	0.3		X Walk 2 Slope (%)	0.7
	X Walk 1 X Slope (%)	0.5		X Walk 2 X Slope (%)	2.4

N/A	Ramp inside XWalk1?	N/A	N/A	Ramp inside XWalk2?	N/A
	Road Slope (%)	3.1		Clear Space?	N/A
	Road X Slope (%)	1.1	N/A	Clear Space to XWalk (in)	N/A
N/A	Any Obstructions?	N/A	N/A	Storm Grate/Utility Hazard?	N/A
	Obstruction Type			Storm Grate/Utility Type	
		N/A			N/A
			Yes	Surface Condition? (G/P)	Good
			No	Curb Slope (%)	23.9

Possible Solutions:

**Remove & Replace Curb Ramp With Two New Directional Ramps or Equivalent.**
