# Access Compliance Report

## Public Rights-of-Way

### (Curb Ramps)

Intersection ID: 31844	Main Street: TIBBLE_CREEK_WY	Cross Street: VICKSBURG_RD	Location: NW
ADA ID: A9F2D3F59828	Ramp Type: Perp	Initial Pass/Fail: Fail	Overall Compliance: No
Codes/Mitigation Info/Possible Solution		Field Measurements/Component Compliance	
Severity Score: 26.25

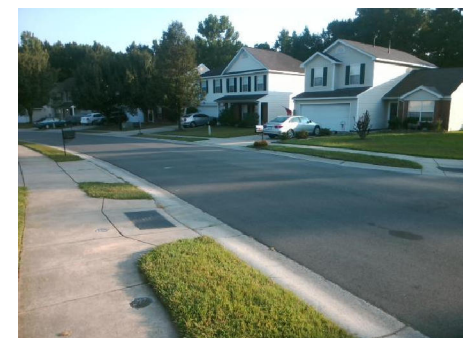
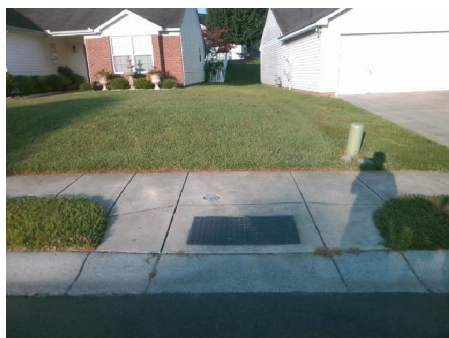
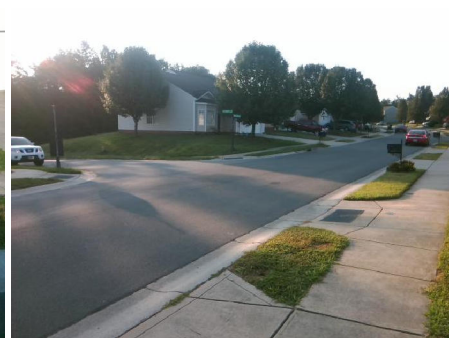
**R304.2.2, R304.5.3**

Compliance	Description	Data	Compliance	Description	Data
N/A	Ramp Length (in)	<b>44.0</b>	No	Ramp Slope (%)	<b>12.2</b>
Yes	Ramp Width (in)	<b>67.0</b>	No	Ramp XSlope (%)	<b>2.8</b>
N/A	Flare Type LT	<b>N/A</b>	N/A	Flare Type RT	<b>N/A</b>
N/A	Flare Slope LT (%)	<b>N/A</b>	N/A	Flare Slope RT (%)	<b>N/A</b>
N/A	Flare Traversable LT?	<b>N/A</b>	N/A	Flare Traversable RT?	<b>N/A</b>
N/A	Landing Length (in)	<b>N/A</b>	N/A	DWS Provided?	<b>N/A</b>
N/A	Landing Width (in)	<b>N/A</b>	N/A	DWS Contrast?	<b>N/A</b>
N/A	Landing Slope (%)	<b>N/A</b>	N/A	DWS Length (in)	<b>N/A</b>
N/A	Landing X Slope (%)	<b>N/A</b>	N/A	DWS Full Width?	<b>N/A</b>
N/A	Landing Curb? (Y/N)	<b>N/A</b>	N/A	DWS Offset (in)	<b>N/A</b>
N/A	Shared Landing?	<b>N/A</b>			
N/A	Gutter Ponding?	<b>N/A</b>	N/A	Gutter Slope (%)	<b>N/A</b>
N/A	Gutter Lip Ht (in)	<b>N/A</b>	N/A	Gutter X Slope (%)	<b>N/A</b>
N/A	Painted X Walk1?	<b>No</b>	N/A	Painted X Walk2?	<b>N/A</b>

X Walk 1 Direction	<b>To NE</b>		X Walk 2 Direction	<b>N/A</b>
N/A	X Walk 1 Width (in)	<b>N/A</b>	N/A	X Walk 2 Width (in)	<b>N/A</b>
	X Walk 1 Slope (%)	<b>1.7</b>		X Walk 2 Slope (%)	<b>N/A</b>
	X Walk 1 X Slope (%)	<b>1.8</b>		X Walk 2 X Slope (%)	<b>N/A</b>
N/A	Ramp inside XWalk1?	<b>N/A</b>	N/A	Ramp inside XWalk2?	<b>N/A</b>
	Road Slope (%)	<b>N/A</b>	N/A	Clear Space?	<b>N/A</b>
	Road X Slope (%)	<b>N/A</b>	N/A	Clear Space to XWalk (in)	<b>N/A</b>
N/A	Any Obstructions?	<b>N/A</b>	N/A	Storm Grate/Utility Hazard?	<b>N/A</b>
	Obstruction Type			Storm Grate/Utility Type	
		<b>N/A</b>			<b>N/A</b>
			Yes	Surface Condition? (G/P)	<b>Good</b>

**Remove & Replace Entire Ramp.**

Total Cost: \$ **1850.00**
