# Access Compliance Report

## Public Rights-of-Way

| Intersection ID: 8312 | Main Street: HOVIS_RD | Cross Street: PONDEROSA_ST | Location: | E |
| ADA ID: A9FA5224F690 | Ramp Type: BlendTrans2 | Initial Pass/Fail: Fail | Overall Compliance: No | Severity Score: 1.25 |

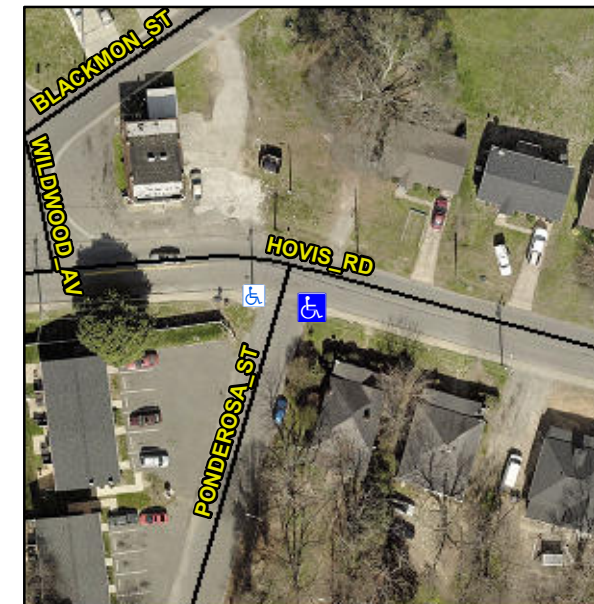
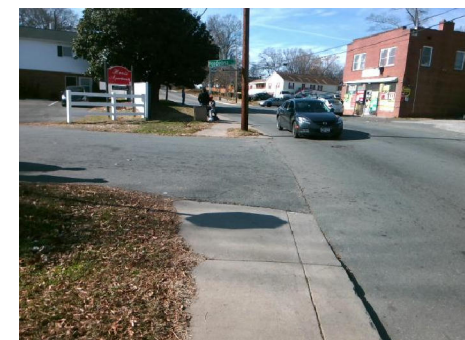
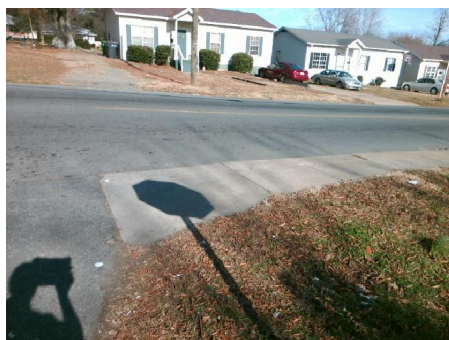
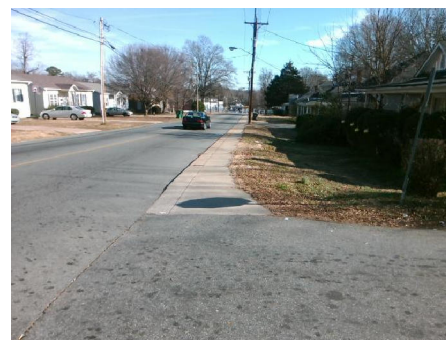
**R304.5.3**

| Compliance | Description | Data | Compliance | Description | Data |
|---|---|---|---|---|---|
| Yes | Ramp Width (in) | 48.0 | No | BlendTrans XSlope (%) | 3.6 |

**Remove & Replace Curb Ramp With Two New Directional Ramps or Equivalent.**

**\$ 3200.00**
