Access Compliance Report

Public Rights-of-Way

(Curb Ramps)

Intersection ID: 48979	Main Street: CALLEY_GLENN_LN	Cross Street: FIVE_KNOLLS_DR	Location: SW
ADA ID: A9FB90B66B1F	Ramp Type: Perp	Initial Pass/Fail: Fail	Overall Compliance: No
Severity Score: 12.5			
Codes/Mitigation Info/Possible Solution		Field Measurements/Component Compliance

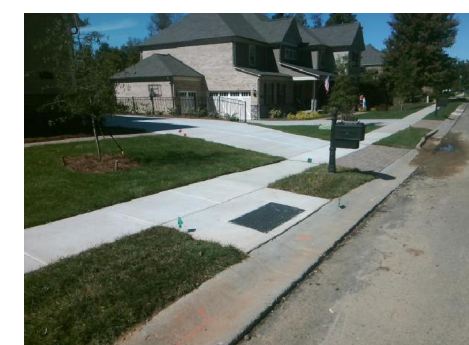
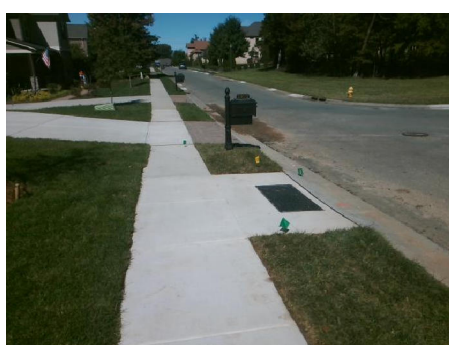
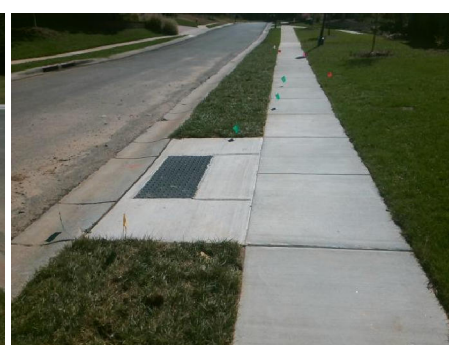
Not Found, R304.5.3

Compliance	Description	Data	Compliance	Description	Data
N/A	Ramp Length (in)	51.5	Yes	Ramp Slope (%)	5.0
Yes	Ramp Width (in)	48.0	No	Ramp XSlope (%)	5.1
N/A	Flare Type LT	N/A	N/A	Flare Type RT	N/A
N/A	Flare Slope LT (%)	N/A	N/A	Flare Slope RT (%)	N/A
N/A	Flare Traversable LT?	N/A	N/A	Flare Traversable RT?	N/A
N/A	Landing Length (in)	N/A	N/A	DWS Provided?	N/A
N/A	Landing Width (in)	N/A	N/A	DWS Contrast?	N/A
N/A	Landing Slope (%)	N/A	N/A	DWS Length (in)	N/A
N/A	Landing X Slope (%)	N/A	N/A	DWS Full Width?	N/A
N/A	Landing Curb? (Y/N)	N/A	N/A	DWS Offset (in)	N/A
N/A	Shared Landing?	N/A			
N/A	Gutter Ponding?	N/A	N/A	Gutter Slope (%)	N/A
N/A	Gutter Lip Ht (in)	N/A	N/A	Gutter X Slope (%)	N/A
N/A	Painted X Walk1?	No	N/A	Painted X Walk2?	N/A
	X Walk 1 Direction	To E		X Walk 2 Direction	N/A
N/A	X Walk 1 Width (in)	N/A	N/A	X Walk 2 Width (in)	N/A
	X Walk 1 Slope (%)	5.1		X Walk 2 Slope (%)	N/A
	X Walk 1 X Slope (%)	1.9		X Walk 2 X Slope (%)	N/A

N/A	Ramp inside XWalk1?	N/A	N/A	Ramp inside XWalk2?	N/A
	Road Slope (%)	N/A	N/A	Clear Space?	N/A
	Road X Slope (%)	N/A	N/A	Clear Space to XWalk (in)	N/A
N/A	Any Obstructions?	N/A	N/A	Storm Grate/Utility Hazard?	N/A
	Obstruction Type			Storm Grate/Utility Type	
		N/A			N/A
			Yes	Surface Condition? (G/P)	Good

Remove & Replace Entire Ramp.
