# Access Compliance Report

### (Curb Ramps)

| Intersection ID: 28614 | Main Street: KESTRAL RIDGE DR | Cross Street: WARBLER WOOD CT | Location: NE |
| ADA ID: A9FC1A5DCC35 | Ramp Type: PerpDiag | Initial Pass/Fail: Fail | Overall Compliance: No |

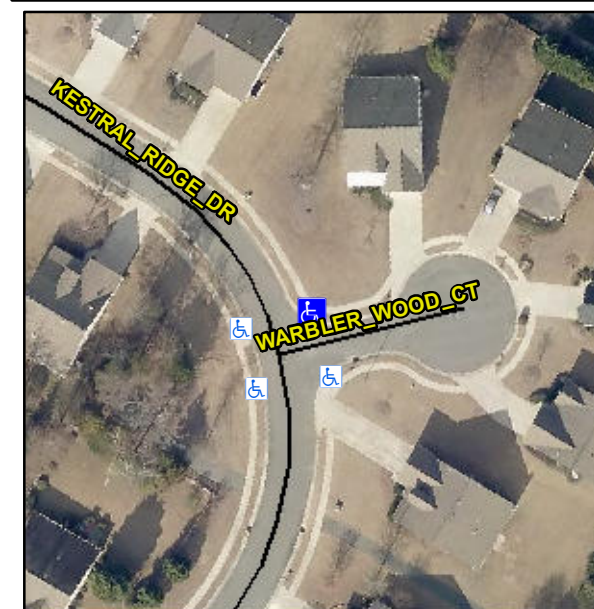
| Severity Score: 12.5 | | | |

**Not Found, R304.2.2**

| Compliance | Description | Data | Compliance | Description | Data |
|---|---|---|---|---|---|
| N/A | Ramp Length (in) | 47.0 | No | Ramp Slope (%) | 11.3 |

**Remove & Replace Curb Ramp With Two New Directional Ramps or Equivalent.**

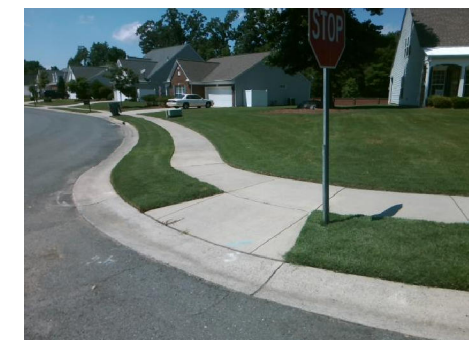
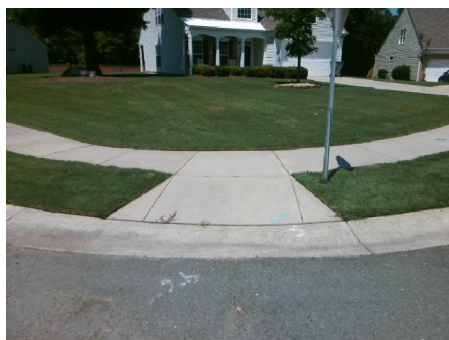
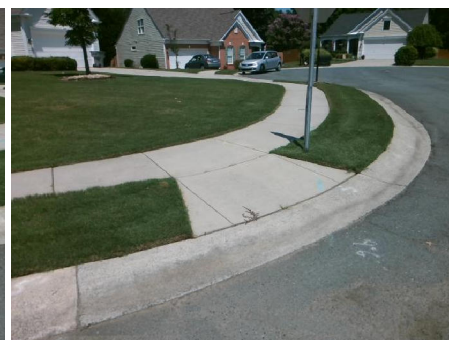
| Compliance | Description | Data | Compliance | Description | Data |
|---|---|---|---|---|---|
| | | | Yes | Surface Condition? (G/P) | Good |
