Access Compliance Report

Public Rights-of-Way

(Curb Ramps)

Intersection ID: 3176	Main Street: OLD_TIMBER_RD	Cross Street: SUTTERS_HILL_CT	Location:	N
ADA ID: A9FDE9A9E914	Ramp Type: Perp	Initial Pass/Fail: Fail	Overall Compliance: No	Severity Score: 1.25
Codes/Mitigation Info/Possible Solution		Field Measurements/Component Compliance

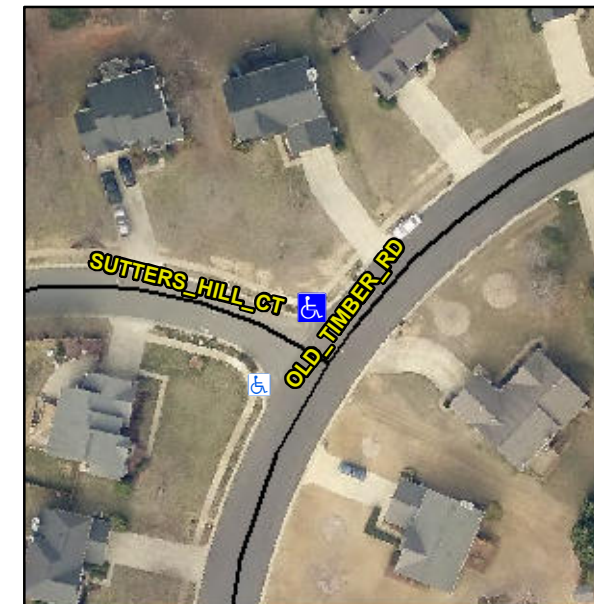
Not Found, R304.5.3

Compliance	Description	Data	Compliance	Description	Data
N/A	Ramp Length (in)	44.5	Yes	Ramp Slope (%)	6.4
Yes	Ramp Width (in)	74.0	No	Ramp XSlope (%)	4.5
N/A	Flare Type LT	N/A	N/A	Flare Type RT	N/A
N/A	Flare Slope LT (%)	N/A	N/A	Flare Slope RT (%)	N/A
N/A	Flare Traversable LT?	N/A	N/A	Flare Traversable RT?	N/A
N/A	Landing Length (in)	N/A	N/A	DWS Provided?	N/A
N/A	Landing Width (in)	N/A	N/A	DWS Contrast?	N/A
N/A	Landing Slope (%)	N/A	N/A	DWS Length (in)	N/A
N/A	Landing X Slope (%)	N/A	N/A	DWS Full Width?	N/A
N/A	Landing Curb? (Y/N)	N/A	N/A	DWS Offset (in)	N/A
N/A	Shared Landing?	N/A			
N/A	Gutter Ponding?	N/A	N/A	Gutter Slope (%)	N/A
N/A	Gutter Lip Ht (in)	N/A	N/A	Gutter X Slope (%)	N/A
N/A	Painted X Walk1?	No	N/A	Painted X Walk2?	N/A
	X Walk 1 Direction	To SW		X Walk 2 Direction	N/A
N/A	X Walk 1 Width (in)	N/A	N/A	X Walk 2 Width (in)	N/A
	X Walk 1 Slope (%)	0.7		X Walk 2 Slope (%)	N/A
	X Walk 1 X Slope (%)	1.0		X Walk 2 X Slope (%)	N/A

N/A	Ramp inside XWalk1?	N/A	N/A	Ramp inside XWalk2?	N/A
	Road Slope (%)	N/A	N/A	Clear Space?	N/A
	Road X Slope (%)	N/A	N/A	Clear Space to XWalk (in)	N/A
N/A	Any Obstructions?	N/A	N/A	Storm Grate/Utility Hazard?	N/A
	Obstruction Type			Storm Grate/Utility Type	
		N/A			N/A
			Yes	Surface Condition? (G/P)	Good

Possible Solutions:

Remove & Replace Entire Ramp.
