# Access Compliance Report

## Public Rights-of-Way

### (Curb Ramps)

| Intersection ID: 10806 | Main Street: MORSON_ST | Cross Street: STATE_ST | Location: SE |

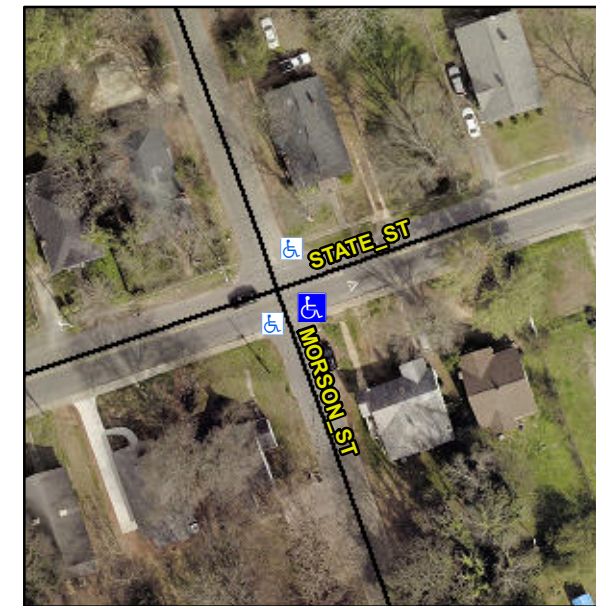
**NO CURB**

**R304.5.1, R304.2.2, R304.5.3**

| Compliance | Description | Data | Compliance | Description | Data |
|---|---|---|---|---|---|
| No | Ramp Width (in) | 37.0 | N/A | Grade Break Slope (%) | 0.0 |
| No | Ramp Slope (%) | 10.0 | N/A | Grade Break XSlope (%) | 0.0 |
| No | Ramp XSlope (%) | 2.6 | | | |

**Remove & Replace Entire Ramp.**
