# Access Compliance Report

## Public Rights-of-Way

### (Curb Ramps)

Intersection ID: 10027950	Main Street: HARDING_PL	Cross Street: N/A	Location: E
ADA ID: A9FFE6BB5643	Ramp Type: Directional1	Initial Pass/Fail: Fail	Overall Compliance: No
		Severity Score: 25

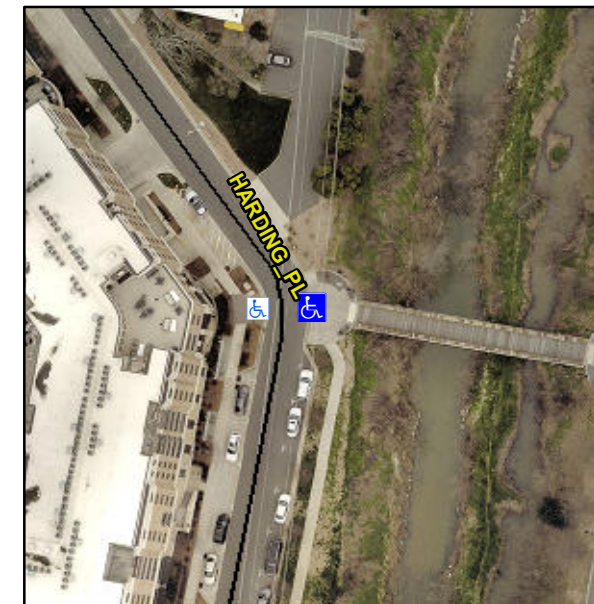
**R304.2.2, R304.5.3**

Compliance	Description	Data	Compliance	Description	Data
N/A	Ramp Length (in)	60.0	N/A	Grade Break?	N/A
Yes	Ramp Width (in)	48.0	N/A	Grade Break Slope (%)	0.0
No	Ramp Slope (%)	8.5	N/A	Grade Break XSlope (%)	0.0
No	Ramp XSlope (%)	5.1			
N/A	Flare Type LT	N/A	N/A	Flare Type RT	N/A
N/A	Flare Slope LT (%)	N/A	N/A	Flare Slope RT (%)	0.0
N/A	Flare Traversable LT?	N/A	N/A	Flare Traversable RT?	N/A
N/A	Landing Length (in)	0.0	N/A	DWS Provided?	N/A
N/A	Landing Width (in)	0.0	N/A	DWS Contrast?	N/A
N/A	Landing Slope (%)	0.0	N/A	DWS Length (in)	N/A
N/A	Landing X Slope (%)	0.0	N/A	DWS Full Width?	N/A
N/A	Landing Curb? (Y/N)	N/A	N/A	DWS Offset LT (in)	N/A
N/A	Shared Landing?	N/A	N/A	DWS Offset RT (in)	N/A
N/A	Gutter Ponding?	0.0	N/A	Gutter Slope (%)	N/A
N/A	Gutter Lip Ht (in)	0.0	N/A	Gutter X Slope (%)	N/A
N/A	Painted X Walk1?	No		Road Slope (%)	11.9
	X Walk 1 Direction	To W		Road X Slope (%)	3.6
	X Walk 1 Width (in)	N/A		Clear Space?	N/A

X Walk 1 Slope (%)	11.9	N/A	Clear Space to XWalk (in)	N/A
	X Walk 1 X Slope (%)	3.6	N/A	Storm Grate/Utility Hazard?	N/A
N/A	Ramp inside XWalk1?	N/A		Storm Grate/Utility Type	
N/A	Any Obstructions?	N/A			N/A
	Obstruction Type		Yes	Surface Condition? (G/P)	Good
			N/A	Curb Slope (%)	18.6

**Remove & Replace Entire Ramp.**
