# Access Compliance Report

## Public Rights-of-Way

### (Curb Ramps)

| Intersection ID: 53762 | Main Street: W_W_T_HARRIS_BV | Cross Street: SINGH_DR | Location: SE |

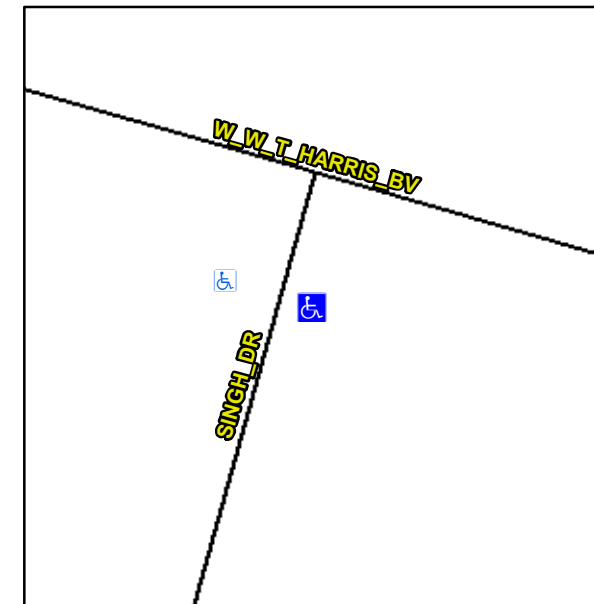
**NO LNDG, NO SWs**

**R304.2.1, R304.2.2-Perp, R304.3.2-  
Para, R304.5.3, R304.5.2**

| Compliance | Description | Data | Compliance | Description | Data |
|---|---|---|---|---|---|
| No | Landing Length (in) | N/A | Yes | DWS Provided? | Yes |
| No | Landing Width (in) | N/A | Yes | DWS Contrast? | Yes |
| No | Landing Slope (%) | N/A | Yes | DWS Length (in) | 24.0 |
| No | Landing X Slope (%) | N/A | Yes | DWS Full Width? | Yes |
| Yes | Gutter Lip Ht (in) | 0.0 | No | Gutter X Slope (%) | 4.5 |

Possible Solutions:

**Remove & Replace Entire Ramp.  
Remove & Replace Gutter.**
