Access Compliance Report Public Rights-of-Way (Curb Ramps)

Intersection ID: 21596 Main Street: HARDISON_RD Cross Street: SHARON_VIEW_RD Location: NE
ADA ID: AA04EB452199 Ramp Type: ParaDiag Initial Pass/Fail: Fail Overall Compliance: No Severity Score: 22.5

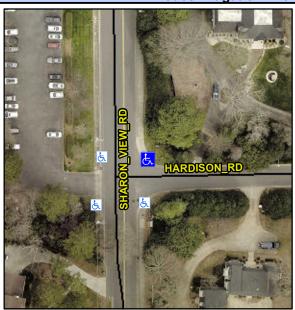
RT RP < 5%

Field Measurements/Component Compilance						
Compliance Description			Data	Compliance Description		Data
1	N/A	Ramp Length LT (in)	58.0	N/A	Ramp Length RT (in)	63.0
1	No	Ramp Width LT (in)	46.0	No	Ramp Width RT (in)	46.0
1	No	Ramp Slope LT (%)	11.6	Yes	Ramp Slope RT (%)	0.3
١	/es	Ramp XSlope LT (%)	1.1	No	Ramp XSlope RT (%)	3.7
N	I/A	Landing Length (in)	N/A	N/A	DWS Provided?	N/A
N	I/A	Landing Width (in)	N/A	N/A	DWS Contrast?	N/A
N	I/A	Landing Slope (%)	N/A	N/A	DWS Length (in)	N/A
N	I/A	Landing X Slope (%)	N/A	N/A	DWS Full Width?	N/A
N	I/A	Landing Curb? (Y/N)	N/A	N/A	DWS Offset (in)	N/A
N	I/A	Shared Landing?	N/A			
N	I/A	Gutter Ponding?	N/A	N/A	Gutter Slope (%)	N/A
N	I/A	Gutter Lip Ht (in)	N/A	N/A	Gutter X Slope (%)	N/A
N	I/A	Painted X Walk1?	No	N/A	Painted X Walk2?	No
		X Walk 1 Direction	To W		X Walk 2 Direction	To S
N	I/A	X Walk 1 Width (in)	N/A	N/A	X Walk 2 Width (in)	N/A
		X Walk 1 Slope (%)	7.3		X Walk 2 Slope (%)	2.1

X Walk 1 X Slope (%)	1.2		X Walk 2 X Slope (%)	5.4
N	I/A	Ramp inside XWalk1?	N/A	N/A	Ramp inside XWalk2?	N/A
		Road Slope (%)	5.1	N/A	Clear Space?	N/A
		Road X Slope (%)	1.8	N/A	Clear Space to XWalk (in)	N/A
1	N/A	Any Obstructions?	N/A	N/A	Storm Grate/Utility Hazard?	N/A
		Obstruction Type			Storm Grate/Utility Type	
			N/A			N/A
				Yes	Surface Condition? (G/P)	Good
				N/A	Curb Slope (%)	23.6
			'	•	,

Remove & Replace Curb Ramp With Two New Directional Ramps or Equivalent.

R304.5.1, R304.3.2, R304.5.3
