Access Compliance Report

Public Rights-of-Way

(Curb Ramps)

Intersection ID: 52521	Main Street: LORNA_ST	Cross Street: MCCLINTOCK_RD	Location: SW
ADA ID: AA0914AD36CB	Ramp Type: Perp	Initial Pass/Fail: Pass	Overall Compliance: No
		Severity Score: 5

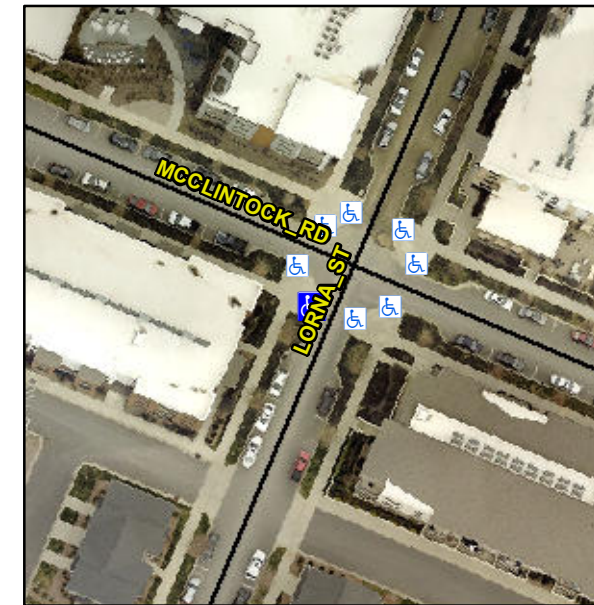
Compliance	Description	Data	Compliance	Description	Data
N/A	Ramp Length (in)	67.0	Yes	Ramp Slope (%)	6.0
Yes	Ramp Width (in)	74.0	Yes	Ramp XSlope (%)	0.3
N/A	Flare Type LT	Sloped	N/A	Flare Type RT	N/A
N/A	Flare Slope LT (%)	6.4	No	Flare Slope RT (%)	10.8
N/A	Flare Traversable LT?	Yes	N/A	Flare Traversable RT?	Yes
Yes	Landing Length (in)	71.0	Yes	DWS Provided?	Yes
Yes	Landing Width (in)	73.0	Yes	DWS Contrast?	Yes
No	Landing Slope (%)	3.3	Yes	DWS Length (in)	24.0
Yes	Landing X Slope (%)	0.1	No	DWS Full Width?	No
N/A	Landing Curb? (Y/N)	No	No	DWS Offset (in)	5.0
N/A	Shared Landing?	Yes			
Yes	Gutter Ponding?	No	Yes	Gutter Slope (%)	1.8
Yes	Gutter Lip Ht (in)	0.0	Yes	Gutter X Slope (%)	0.7
N/A	Painted X Walk1?	No	N/A	Painted X Walk2?	N/A
	X Walk 1 Direction	To SE		X Walk 2 Direction	N/A
N/A	X Walk 1 Width (in)	N/A	N/A	X Walk 2 Width (in)	N/A
	X Walk 1 Slope (%)	4.1		X Walk 2 Slope (%)	N/A
	X Walk 1 X Slope (%)	1.9		X Walk 2 X Slope (%)	N/A

N/A	Ramp inside XWalk1?	N/A	N/A	Ramp inside XWalk2?	N/A
	Road Slope (%)	N/A	N/A	Clear Space?	Yes
	Road X Slope (%)	N/A	N/A	Clear Space to XWalk (in)	N/A
Yes	Any Obstructions?	No	Yes	Storm Grate/Utility Hazard?	No
	Obstruction Type			Storm Grate/Utility Type	
		N/A			N/A
			Yes	Surface Condition? (G/P)	Good

Possible Solutions:

Remove & Replace Entire Ramp.
